Ethernet Routing Switch 3500 Series Software Release 5.0.2

1. Release Summary

Release Date: 26-November-2012 Purpose: Software maintenance release to introduce new features, as well as to address customer and internally found software issues.

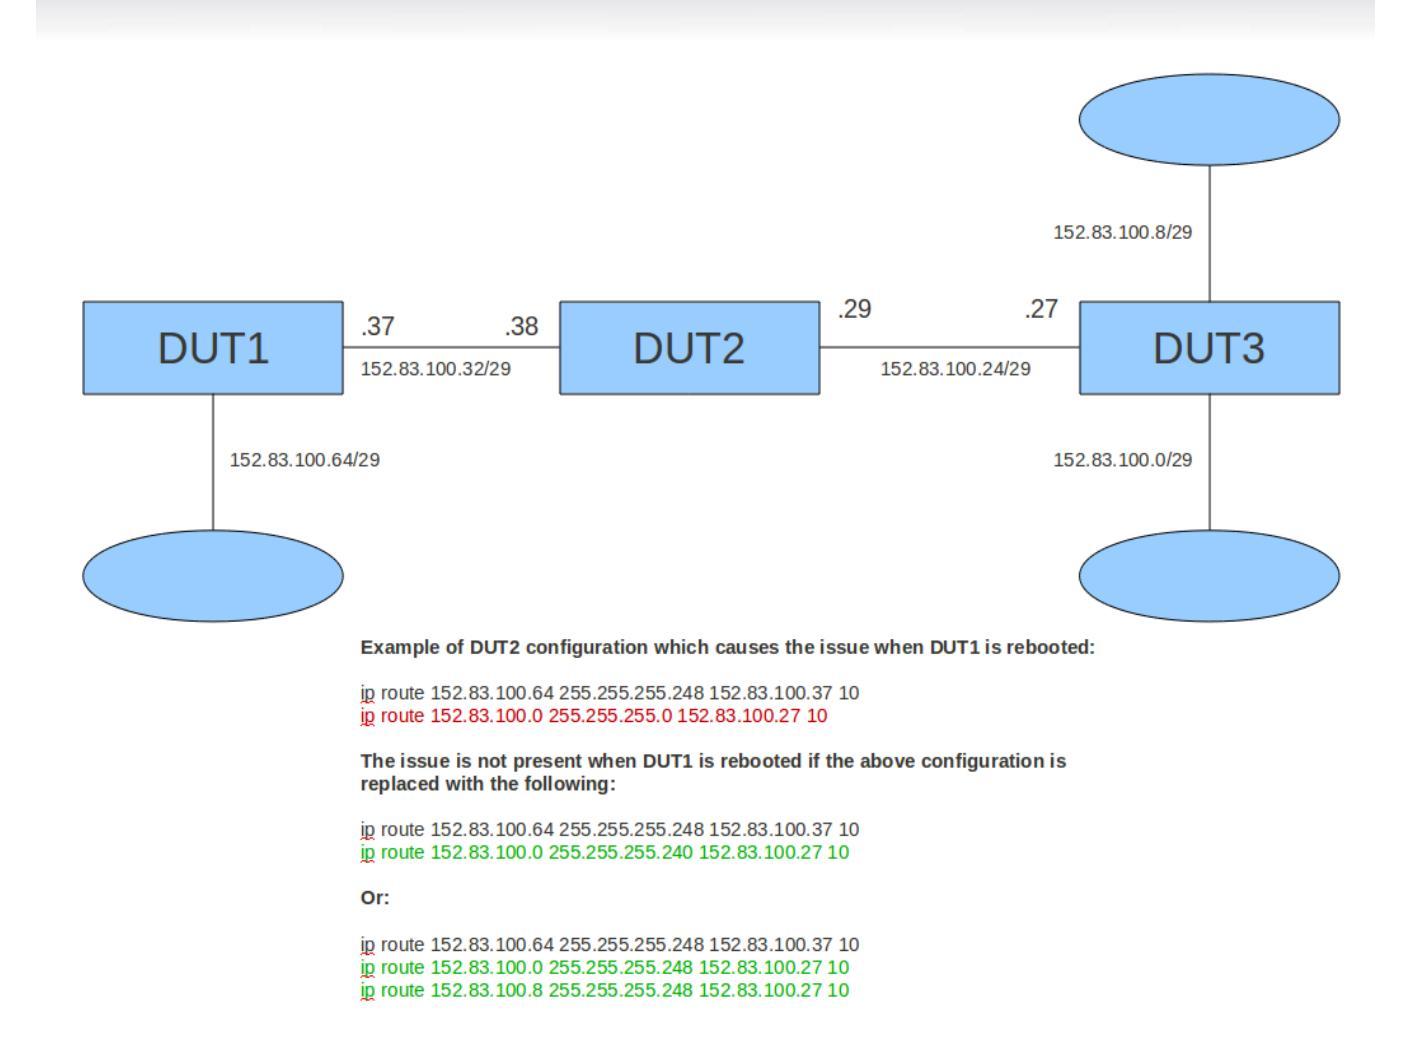
Figure 1 : Sample network

Static route remains inactive after being recursively resolved through a redundant route even after the next hop becomes accessible again. This happens because of the summary route. The workaround is to disable and reenable IP routing.

On DUT2, network 152.83.100.64/24 is reachable via DUT1 interface

152.83.100.37 (a static route is configured). Also, to achieve connectivity with 152.83.100.0/29 and 152.83.100.8/29 networks, a static route 152.83.100.0/24 with next-hop 152.83.100.27 (DUT3) is configured. This is a summary route and aggregates all the 152.83.100.x/29 networks in the setup.

When DUT1 is unavailable (rebooted), a route to 152.83.100.64/29 would become a non-local static route due to the next-hop 152.83.100.37/29 being resolved recursively through the summary route 152.83.100.0/24 next-hop 152.83.100.27/29 (DUT3). Thus, the 152.83.100.64/29 network would wrongly appear to be reachable via DUT3 interface 152.83.100.27. This happens because of the IP route summarization.

When DUT1 becomes available again, the route 152.83.100.64/29 through DUT1 (next-hop 152.83.100.37/29) does not recover.

The workaround for the above issue is to disable and re-enable IP routing on DUT2.

The issue can be prevented by a proper design of the addressing plan so that the IP summarization can take effect.

In Figure 1, we are provided with two examples that can successfully replace the initial configuration. With these configurations the issue described above will be avoided. In both examples, the summary route 152.83.100.0/24 is replaced with a more specific summary route (152.83.100.0/28) or with routes to each different subnet.
