Release Notes: ISW Series 12-Port Industrial Switches

Firmware Version 1.01.03.0013

FW Release Version: v01.01.03.0013 (for all models)

Documentation Date: 2021/05/11

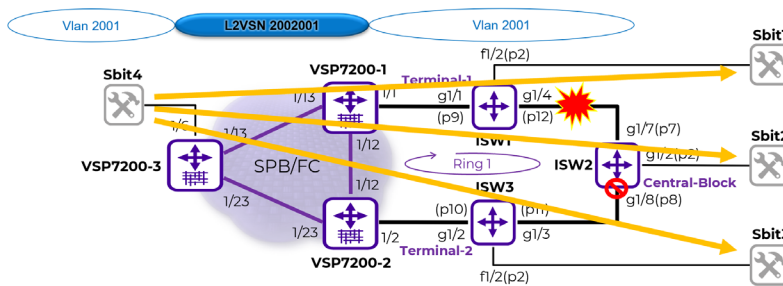
- TCN (topology change notification) of MSTP.
ISW Ringv2(Chain/Balancing Chain) support MSTP/RSTP TCN BPDUs for fast (less than 100ms) network redundancy recovery time.

- Ring Cut (64 milliseconds interruption)

- Ring Restore (65 milliseconds interruption)

Verified: ISW of TCN BDUs for fast aging of MACs on Fabric Core whenever ISW ring is cut or restored. (Less than 100ms)
