# Release Notes: ISW Series 8-Port Industrial Switches

## Firmware Version 1.01.03.0013

**FW Release Version:** v01.01.03.0013 (for all models)

**Documentation Date:** 2021/05/11

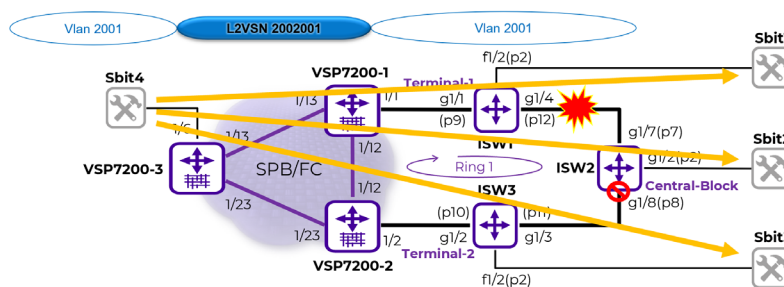
ISW Ringv2(Chain/Balancing Chain) support MSTP/RSTP TCN BPDUs for fast (less than 100ms) network redundancy recovery time.

- Ring Cut (64 milliseconds interruption)

- Ring Restore (65 milliseconds interruption)

Verified: ISW of TCN BDUs for fast aging of MACs on Fabric Core whenever ISW ring is cut or restored. (Less than 100ms)
