Release Notes: ISW Series 8-Port Industrial Switches

Firmware Version 1.01.03.0014 (for all models)

ISW 4-10/100P, 2-10/100T, 2-SFP, PoE Switch
ISW 4GbP, 2GbT, 2-SFP, PoE Switch

Documentation Date: 2021/10/29

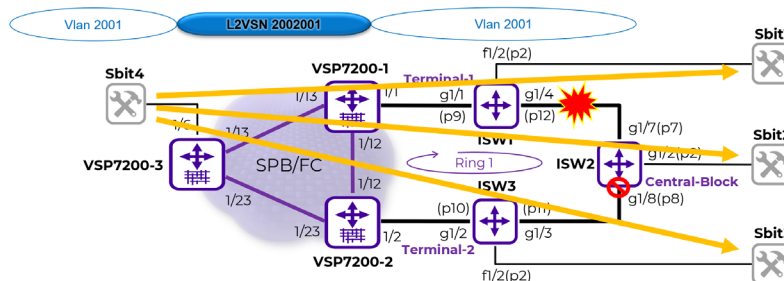
1. TCN (topology change notification) of MSTP.
ISW Ringv2(Chain/Balancing Chain) support MSTP/RSTP TCN BPDU for fast (less than 100ms) network redundancy recovery time.

- Ring Cut (64 millisecs interruption)

- Ring Restore (65 millisecs interruption)

Verified: ISW of TCN BDUs for fast aging of MACs on Fabric Core whenever ISW ring is cut or restored. (Less than 100ms)
