Release Notes: ISW Series 8-Port Industrial Switches

Firmware Version 1.01.03.0015 (for all models)

Documentation Date: 2022/02/18

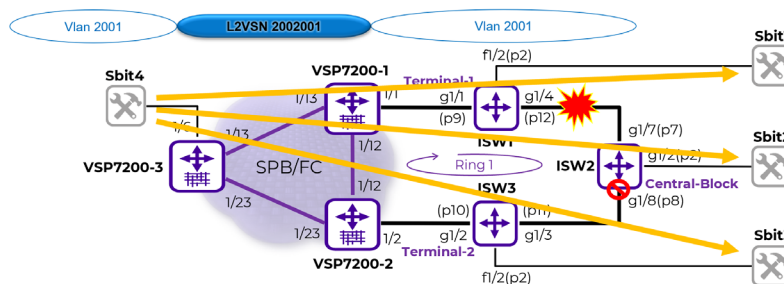
1. TCN (topology change notification) of MSTP.
ISW Ringv2(Chain/Balancing Chain) support MSTP/RSTP TCN BPDUs for fast (less than 100ms) network redundancy recovery time.

Verified: ISW of TCN BDUs for fast aging of MACs on Fabric Core whenever ISW ring is cut or restored. (Less than 100ms)
