Avaya Virtual Services Platform 9000

Important Notice

CP Module Compact Flash Replacement

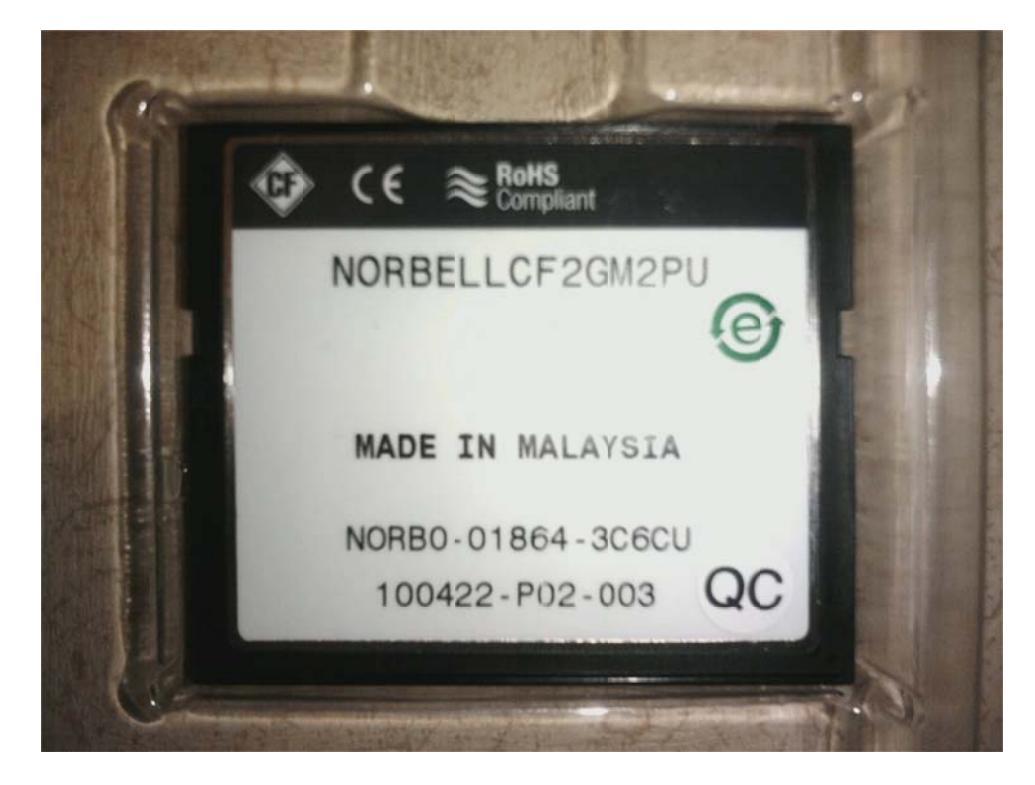
If a 9080 CP module is reset during a DMA write to the CF card, the CF card can become non-responsive to additional read or write requests until the 9080 CP module has been power cycled. This problem can occur with both the internal and external CF cards. You must replace both CF cards and return the cards to Avaya for reformatting and a microcode update.

You can visually inspect the cards to determine if they are one of the early models. Disable the CP module and remove it from the chassis. The early models, both internal and external, have the QC label printed in black text on a white label and the part number ends with *M2PU*. Replace this CF card with the newer CF card. See the following figure for an example of an early model CF card.

Figure 1. Suspect internal CF card (needs to be replaced)

- 10. Remove the Backup CP module from the chassis.
- 11. Replace both the internal and external flash cards on the removed module. To replace the internal flash card:
 - a. Place a piece of magic or scotch tape on top of the internal flash card to form a pull tab. Pull away from the front of the card.

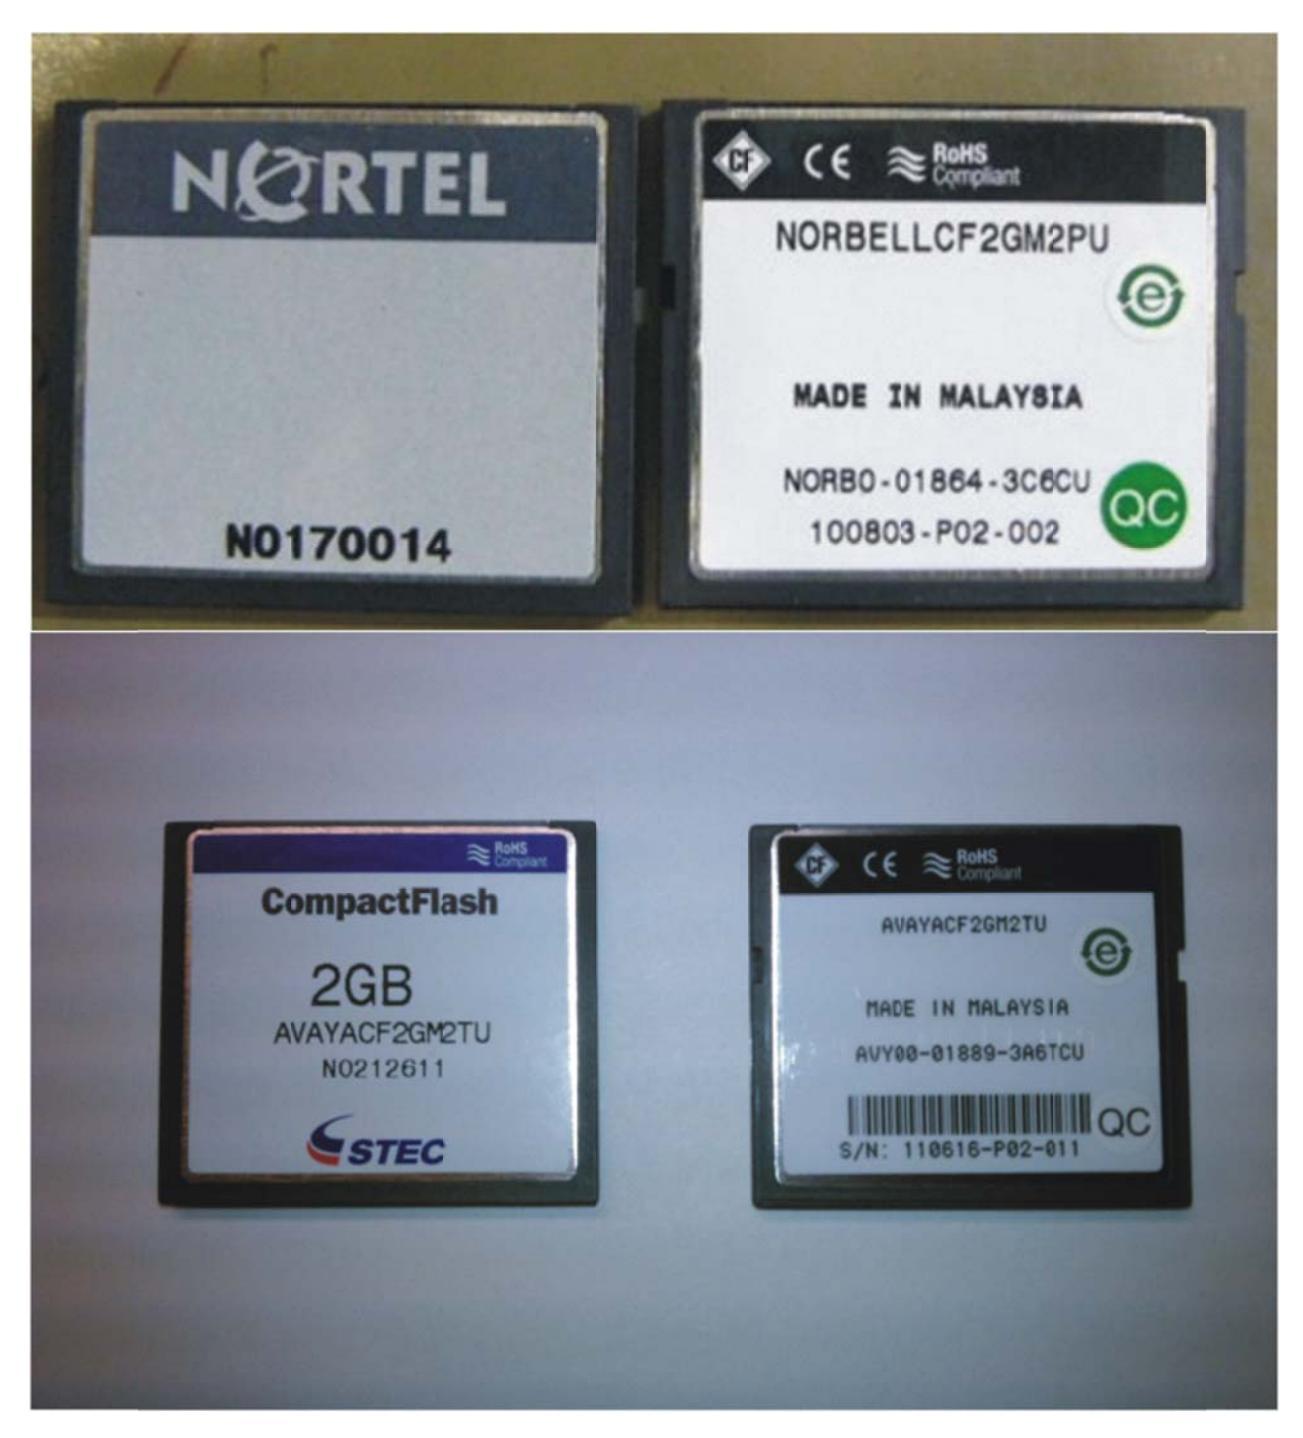
The newer CF cards, without the errata, use a part number that ends with *M2TU* and have a QC label printed in black text on a white label. CF cards that use a part number that ends with *M2PU* but have a QC label printed in white text on a green label are also acceptable. See the following figure for examples of a new internal CF card.

Figure 2. Front and rear view of good internal CF cards (without microcode errata)
