Ethernet Routing Switch 5000 Series Software Release 6.3.2

1. Release Summary

Purpose: Software patch release to address customer and internally found software issues.

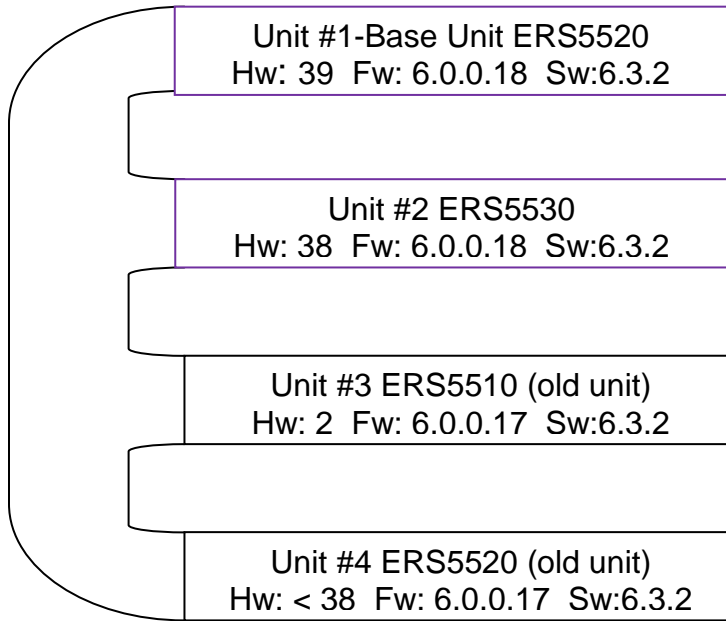
When performing image agent downgrade, if **new units** are present in stack, a warning message will be generated to verify the diagnostic versions for all units in stack

```
">% WARNING: units with newer hw revision in stack.  
    All units should run 6.0.0.18 diagnostic version or newer.  
    Do you want to continue (y/n)?"
```

Figure 1: No diagnostic downgrade allowed on the stack above.
New 5520/5530 units detected.

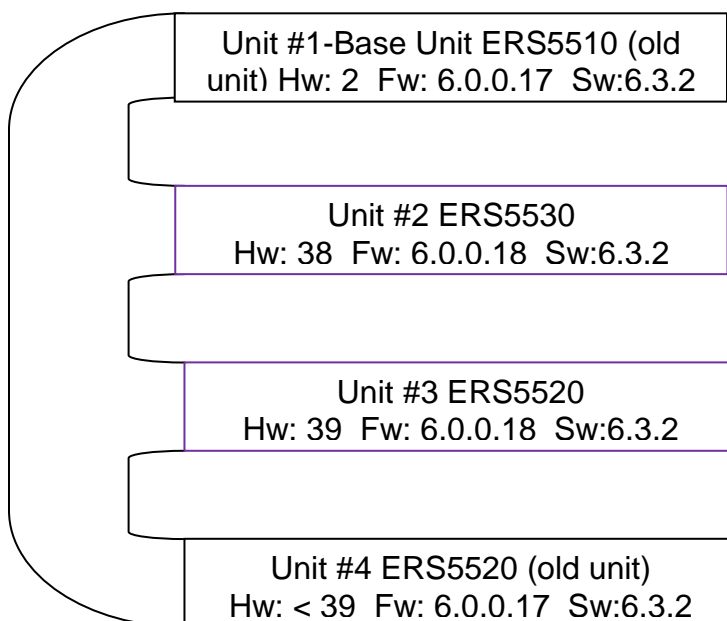
When performing image agent downgrade, if BU has a diagnostic image prior to 6.0.0.18 and **new units** are in the stack, no agent image downgrade will be performed and the following error message will be displayed:

`"% Software downgrade not supported. BU has older diagnostic."`

Figure 2: No agent image downgrade will be allowed for this stack, BU has an older diagnostic (prior to 6.0.0.18) version and **new units** are in stack.

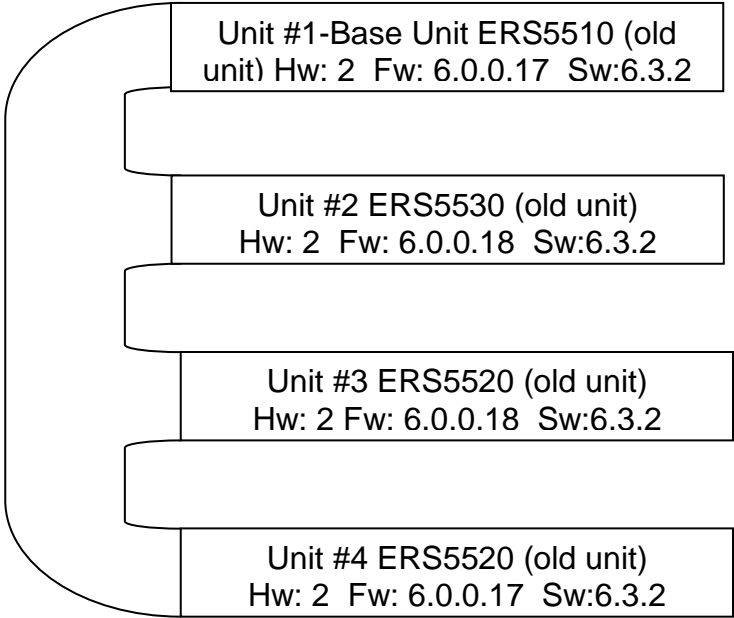
When performing image agent downgrade, if BU has a diagnostic image prior to 6.0.0.18 and there are no **new units** in the stack, the agent image downgrade will be performed.

Figure 3: Agent image downgrade will be allowed for this stack even if BU has an older diagnostic (prior to 6.0.0.18) and there are no **new units** in the stack.

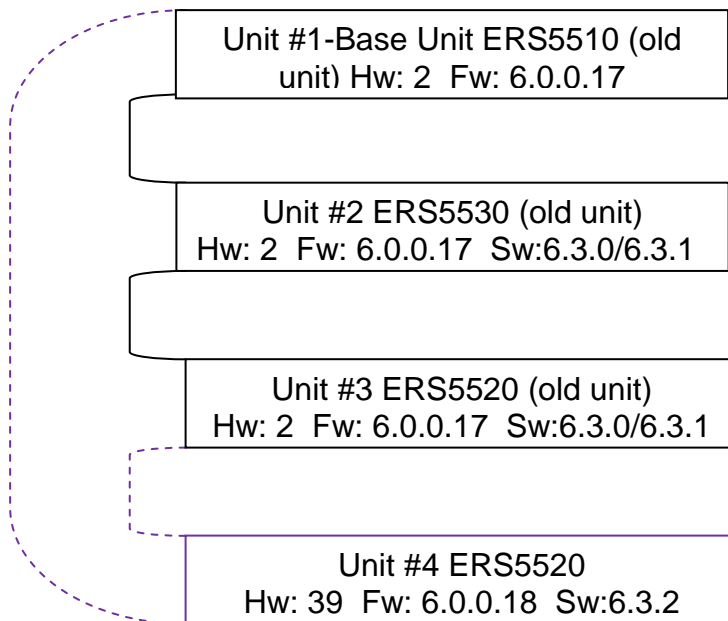
When **new units** are added to a stack with DAUR running, older agent images (6.3.0 or 6.3.1) won't transfer the agent image if the BU's diagnostic isn't 6.0.0.18 or newer.

"AAUR - The hardware is not compatible with stack diagnostic %s version"

Figure 4: A **new unit** running SW 6.3.2 added to a stack running an older agent image that supports DAUR won't transfer the image if the BU diagnostic is not 6.0.0.18 or newer.

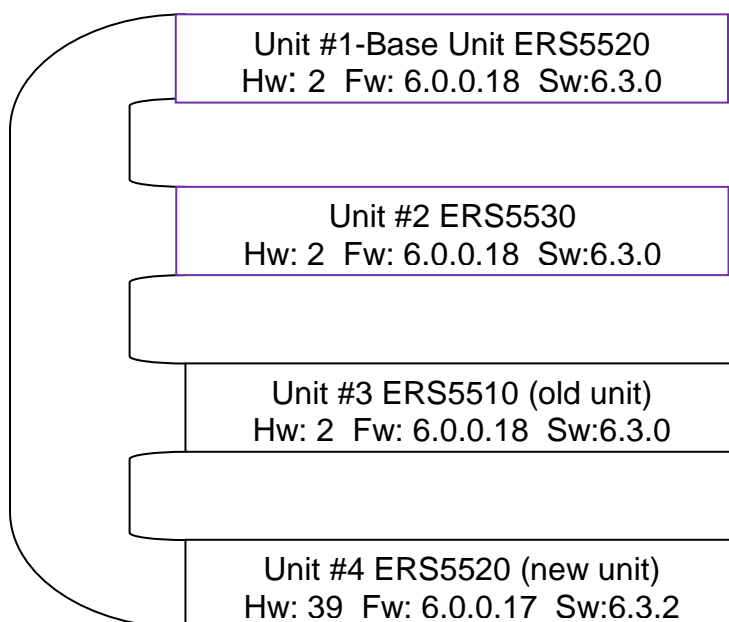
When the base unit has the 6.0.0.18 diagnostic, a **new unit** will accept the agent download from the base.

Figure 5: A **new unit** running SW 6.3.2 added to a stack running an older agent image that supports DAUR will transfer the image if the BU diagnostic is 6.0.0.18 or newer .

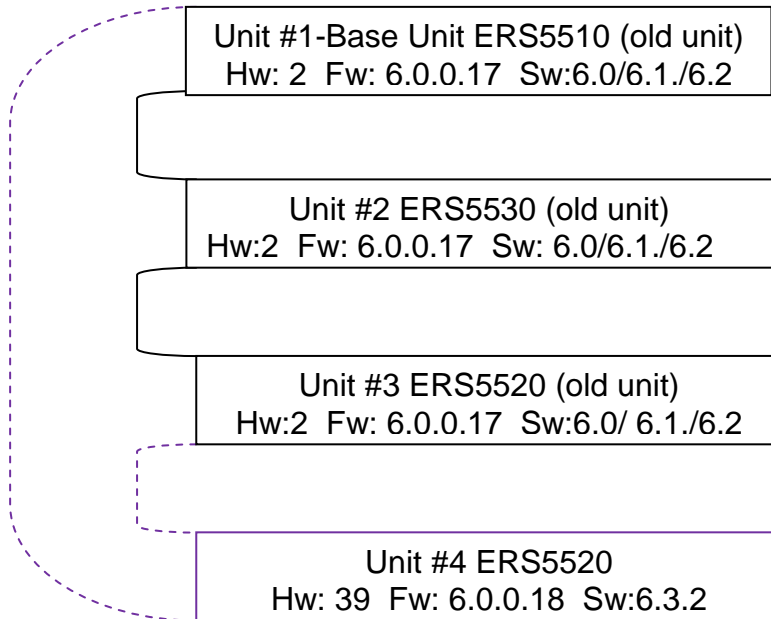
A **new unit** added to a stack not supporting DAUR will transfer the agent image regardless of BU's diagnostic version.

Figure 6: A **new unit** running SW 6.3.2 added to a stack running an older agent image that doesn't support DAUR will transfer the agent image regardless of BU diagnostic version.

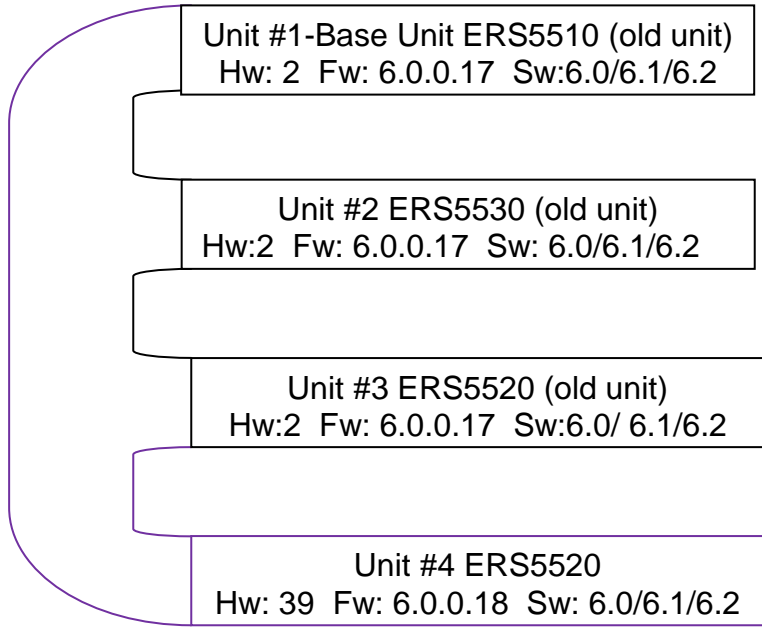
Step 1: a **new unit** running SW 6.3.2 is added to a stack running an older agent image that does not support DAUR will transfer the agent image regardless of BU diagnostic version(Figure 6) and after image transfer the **new unit** will join the stack.

Figure 7: A Stack running SW 6.0/6.1/6.2 and having a **new unit** with different diagnostic than the BU's diagnostic

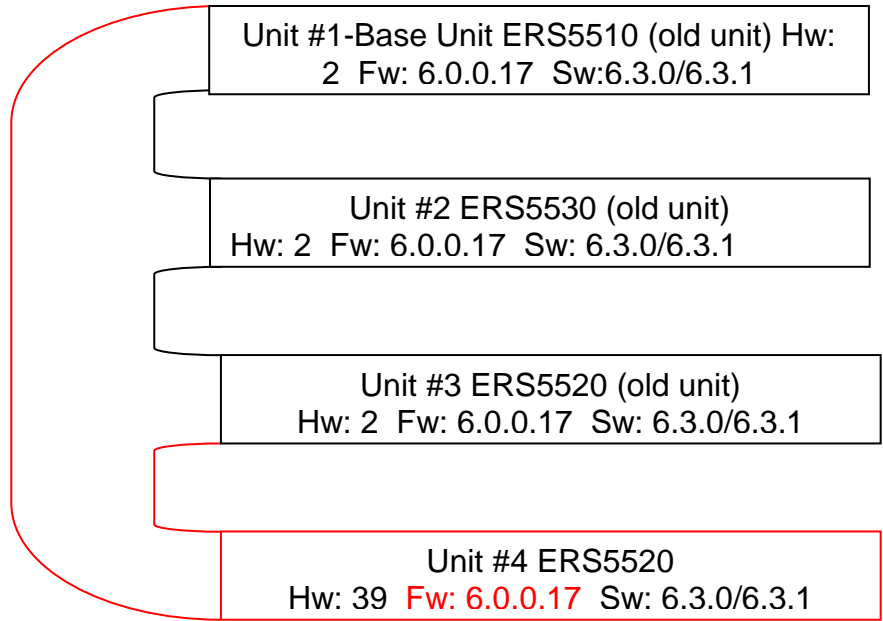
-**Step 2:** If the stack's agent image from Step 1 is upgraded to a release supporting DAUR (6.3.0/6.3.1), the ***new unit*** won't be allowed to join the stack and the diagnostic transfer will occur, leading to a faulty unit.

Figure 8: For the stack above DAUR will be performed on the ***new unit***.

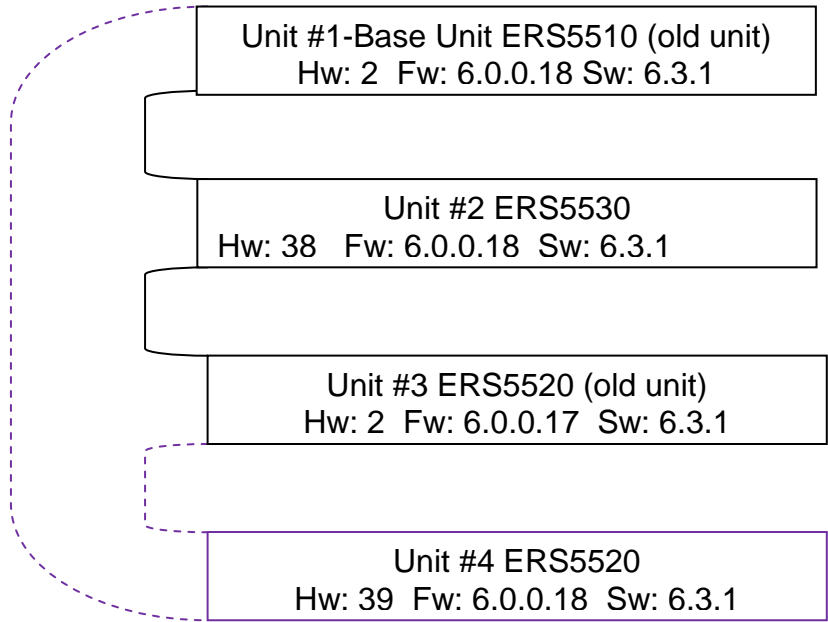
-Step 1: Downgrade previous 6.3.2 SW agent images on a 6.3.2 stack having **new units**

Figure 9: A stack with SW prior to 6.3.2 and base unit diagnostic firmware 6.0.0.18

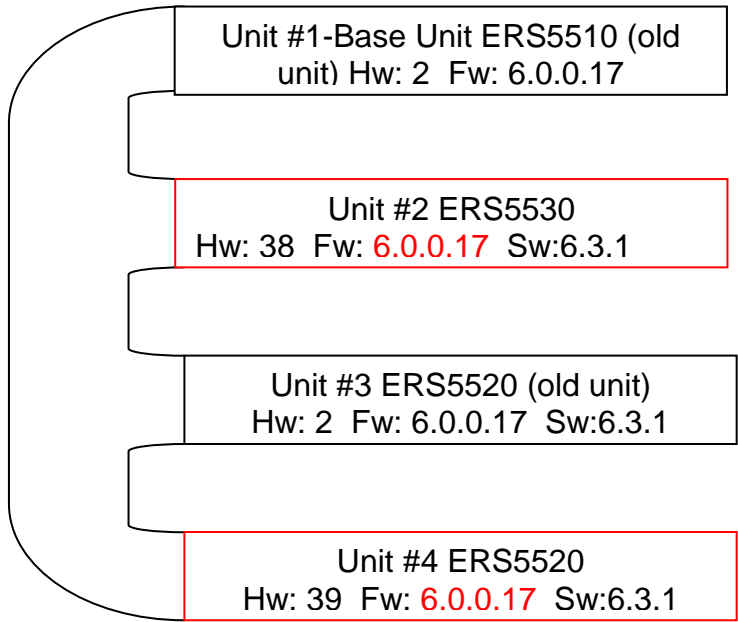
-**Step 2:** downgrade to a diagnostic version prior to 6.0.0.18. Diagnostic downgrade will lead to faulty units.

Figure 10: A stack having prior to 6.3.2 SW and downgrading to a diagnostic version prior to 6.0.0.18

Using the stack from Figure 10: the BU has dual agent configured and the boot image from the other block is a version that supports DAUR (6.3.0 or 6.3.1) if for an unknown reason the agent image from the first block gets corrupted the agent image from the other block is used and AAUR followed by DAUR will be performed on **new units**.
