# Ethernet Routing Switch

## 8300

### Software Release 3.0.x.x

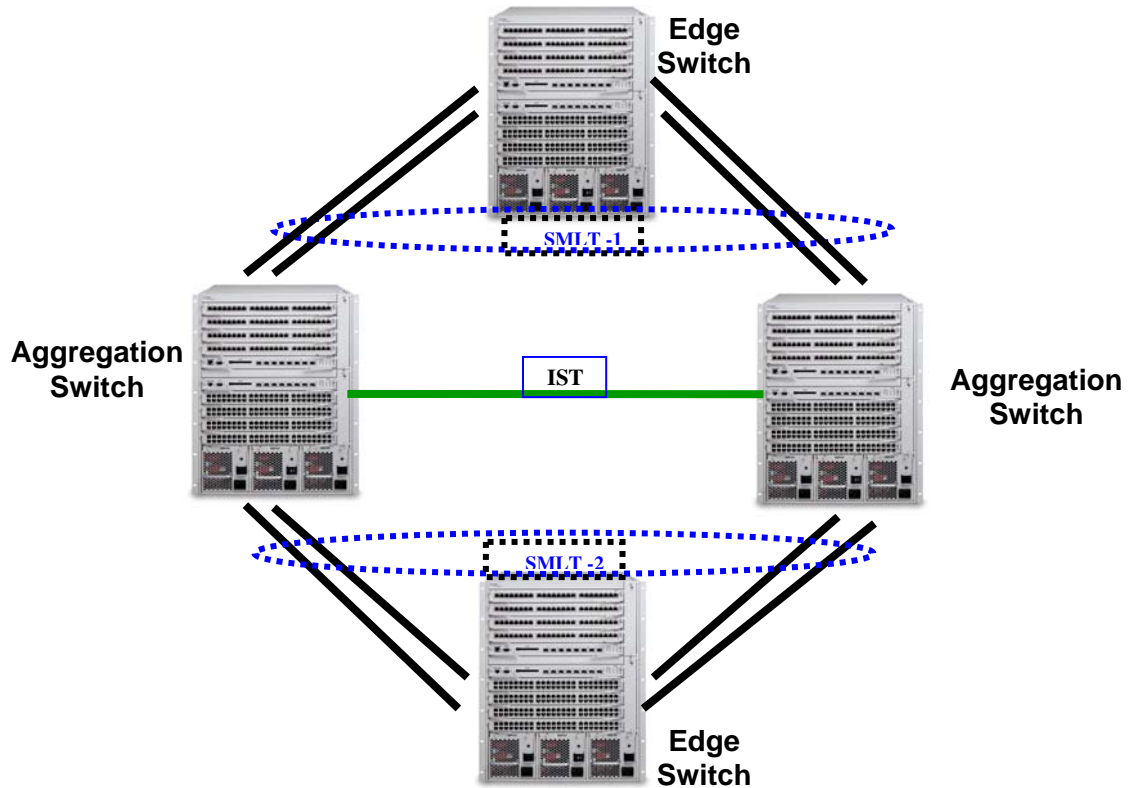
Note: Here is a example for the diamond SMLT topology

In a diamond SMLT topology consisting of 4 ERS8300 devices, the booting with factory default configuration of the edge switch now doesn't cause the system instability of the aggregation switch. (Q01475259)
