Ethernet Routing Switch

8300

Software Release 3.0.x.x

Software Release 3.0.3.0

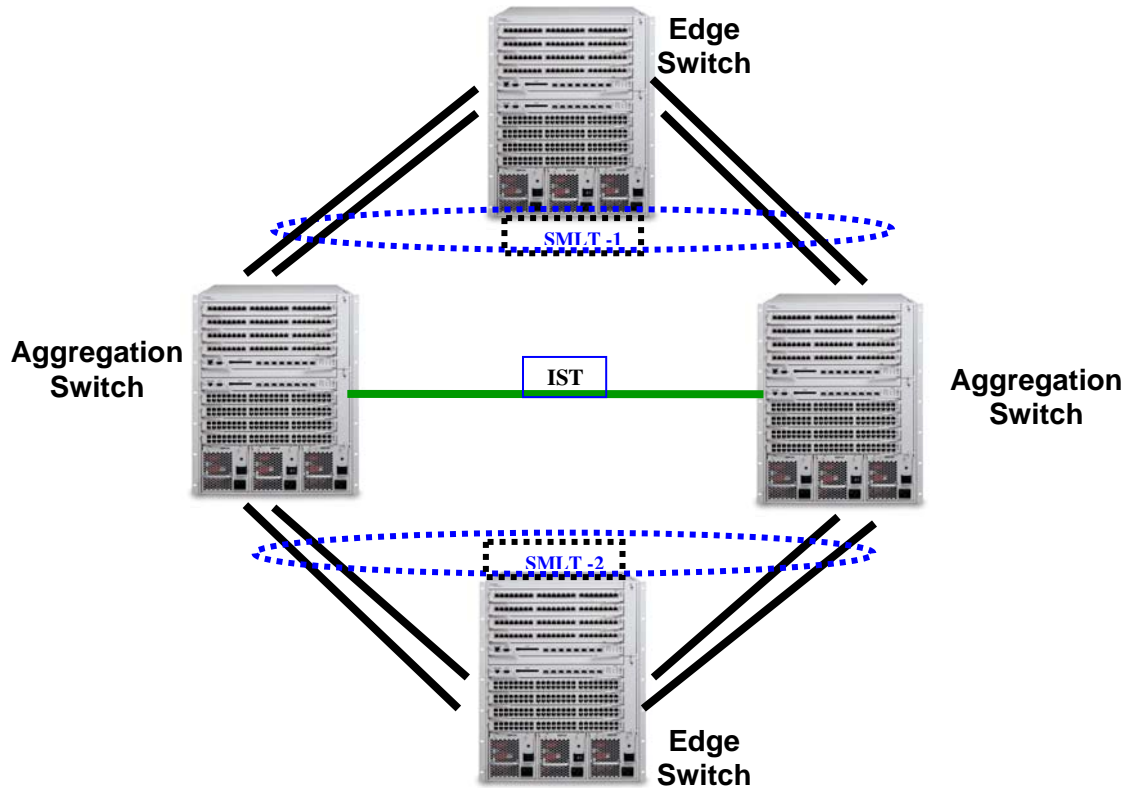
Note: Here is a example for the diamond SMLT topology

In a diamond SMLT topology consisting of 4 ERS8300 devices, the booting with factory default configuration of the edge switch now doesn't cause the system instability of the aggregation switch. (Q01475259)
