Ethernet Routing Switch 8300

Software Release 4.2.3.11

Purpose : Software maintenance release to address a specific customer found issue.

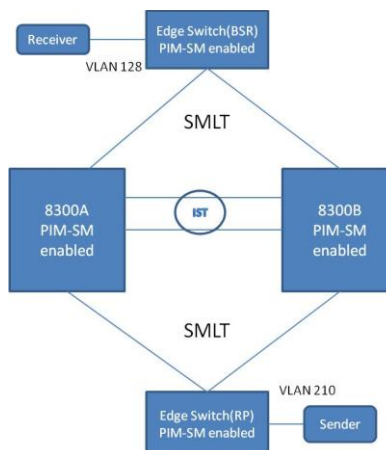
- For the scenario where the IST/SMLT switches are configured as Layer-3 transit network for multicast stream and the multicast source and receiver are located on two different SMLT edge switches of the same IST peer cluster, a PIM Multicast routing loop may occur over IST links. This scenario can now be avoided by enabling a new CLI/ACLI parameter called pim-ist-protect. By default, it is disabled and will need to be turned on to handle the above scenario [WI01088695]

Example configuration of sender and receiver on different edge switches of the same IST cluster.

PPCLI(rwa/rwa):
 config pim-ist-protect <enable | disable | info>

ACLI(rwa/rwa):
 config t;
 pim-ist-protect;
 <no | default> pim-ist-protect;
 show pim-ist-protect;
