Ethernet Routing Switch 8300

Software Release 4.2.3.12	2
Software Release 4.2.3.11	5
Software Release 4.2.3.10	8
Software Release 4.2.3.9	12
Software Release 4.2.3.8	15
Software Release 4.2.3.7	18
Software Release 4.2.3.6	21
Software Release 4.2.3.5	25
Software Release 4.2.3.4	27
Software Release 4.2.3.3	30
Software Release 4.2.3.2	33
Software Release 4.2.3.0	36

Software Release 4.2.3.12

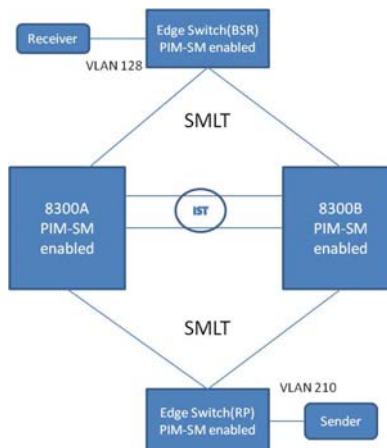
- For the scenario where the IST/SMLT switches are configured as Layer-3 transit network for multicast stream and the multicast source and receiver are located on two different SMLT edge switches of the same IST peer cluster, a PIM Multicast routing loop may occur over IST links. This scenario can now be avoided by enabling a new CLI/ACLI parameter called pim-ist-protect. By default, it is disabled and will need to be turned on to handle the above scenario [WI01088695]

Example configuration of sender and receiver on different edge switches of the same IST cluster.

Syntax:

PPCLI(rwa/rwa):
 config pim-ist-protect <enable | disable | info>

ACLI(rwa/rwa):
 config t;
 pim-ist-protect;
 <no | default> pim-ist-protect;
 show pim-ist-protect;
