Ethernet Routing Switch 8300

Software Release 4.2.3.13

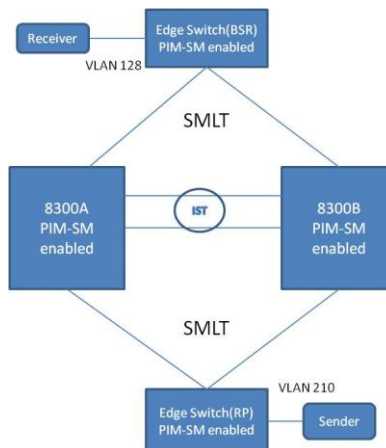
- For the scenario where the IST/SMLT switches are configured as Layer-3 transit network for multicast stream and the multicast source and receiver are located on two different SMLT edge switches of the same IST peer cluster, a PIM Multicast routing loop may occur over IST links. This scenario can now be avoided by enabling a new CLI/ACLI parameter called pim-ist-protect. By default, it is disabled and will need to be turned on to handle the above scenario [WI01088695]

Example configuration of sender and receiver on different edge switches of the same IST cluster.

Syntax:

PPCLI(rwa/rwa):
 config pim-ist-protect <enable | disable | info>

ACLI(rwa/rwa):
 config t;
 pim-ist-protect;
 <no | default> pim-ist-protect;
 show pim-ist-protect;
