# Ethernet Routing Switch 8300

Software Release 4.2.3.14

Purpose : Software maintenance release to address specific customer found issues.

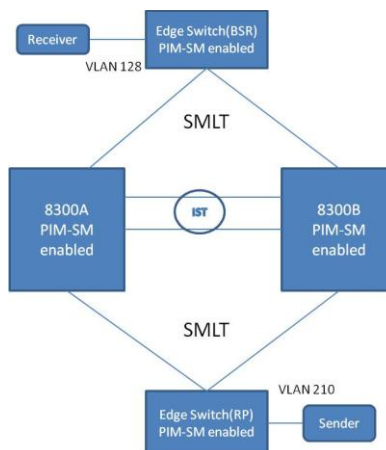
*Example configuration of sender and receiver on different edge switches of the same IST cluster.*

- For the scenario where the IST/SMLT switches are configured as Layer-3 transit network for multicast stream and the multicast source and receiver are located on two different SMLT edge switches of the same IST peer cluster, a PIM Multicast routing loop may occur over IST links. This scenario can now be avoided by enabling a new CLI/ACLI parameter called pim-ist-protect. By default, it is disabled and will need to be turned on to handle the above scenario [WI01088695]

Syntax:

PPCLI(rwa/rwa):  
 config pim-ist-protect <enable | disable | info>

ACLI(rwa/rwa):  
 config t;  
 pim-ist-protect;  
 <no | default> pim-ist-protect;  
 show pim-ist-protect;
