Part No. 208560-C
March 2003

Release Notes for the BayStack 10 Power Supply Unit

Software Version 3.0.0

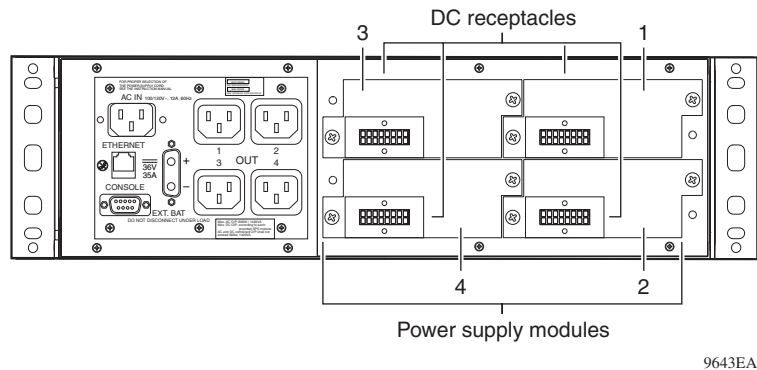
Figure 1 Rear panel of UPS with RPS configuration

Additional labels appear on the rear panel of the UPS, as shown in Figure 1.
