Nortel Ethernet Routing Switch 5000 Series

Release Notes — Release 6.0

Document status: Standard
Document version: 04.02
Document date: 18 March 2009

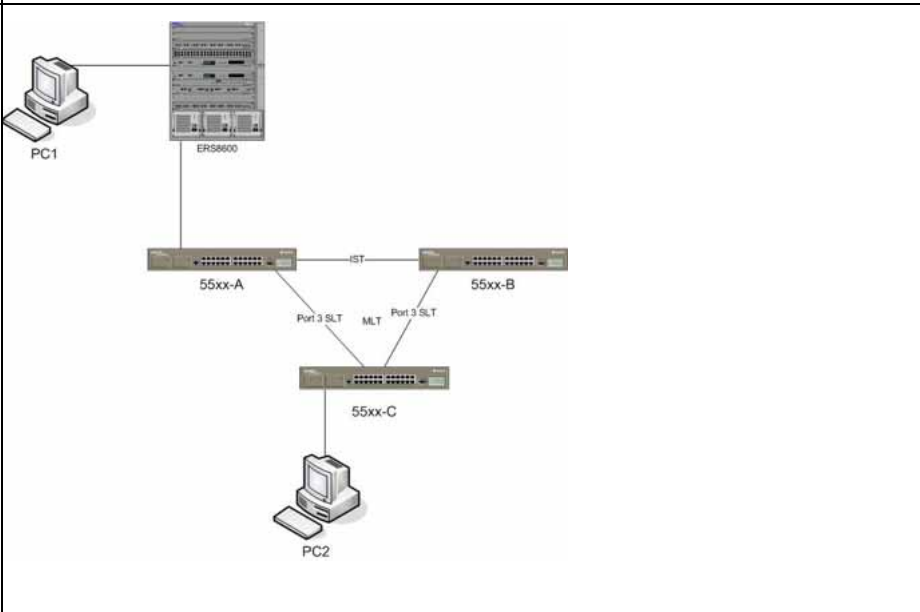
<p data-bbox="464 903 1390 1018">In the preceding figure, 86xx has two routes to reach PC2. The first route is to 55xx-a and then 55xx-c. The second route is to 55xx-b and then 55xx-c. If 8600 uses second route, the traffic from PC1 will never reach PC2.</p> <p data-bbox="464 1018 1390 1102">To force the 86xx to take the first route, you must configure VRRP with Backup/Master enabled on both SMLT switches.</p> <p data-bbox="464 1102 1390 1178">Then static route with the best cost to the VRRP must be added to 86xx to make sure 86xx always chooses 55xx-a as the next hop to reach PC2.</p>
Q01738603	If you use the non-EAP phone feature in Layer 3 mode with DHCP Relay, it may disrupt Layer 3 connectivity. Nortel recommends that you deploy this feature only in Layer 2 mode.
Q01738540	A hardware limitation means that once you program the filter, it blocks all IPs that are not allowed. The switch does not show which IP was dropped.
