Avaya WLAN 8100 Release Notes

1.2.0.0
NN47251-400, 04.01
April 2012

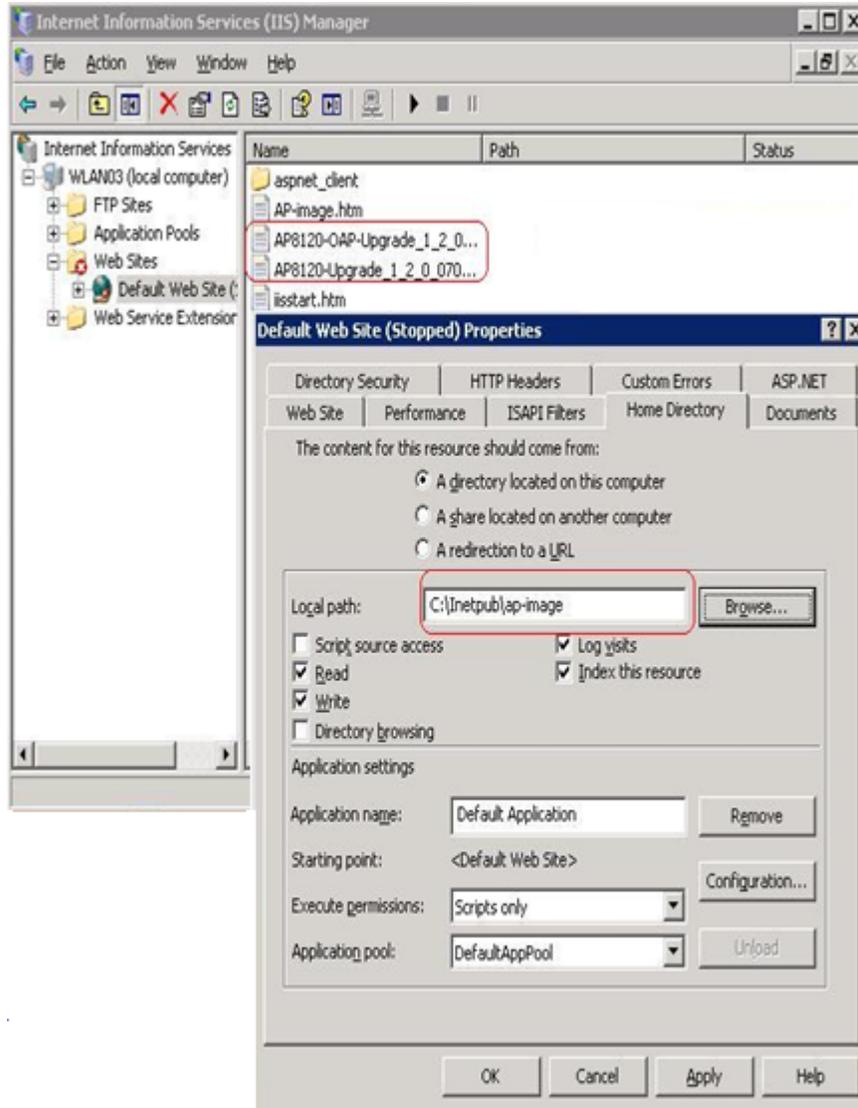
1. On your PC navigate to: **Start, Programs, Administrative Tools, Internet Information Services.**
2. Copy the files from the new user created folder in **c:\inetpub\ap-image. Ap-image.**
3. Browse the same folder in the local path field under the **Home Directory** tab. Enable the read and write permissions as shown in the following graphic.

Figure 1: Windows internet information services Home Directory tab

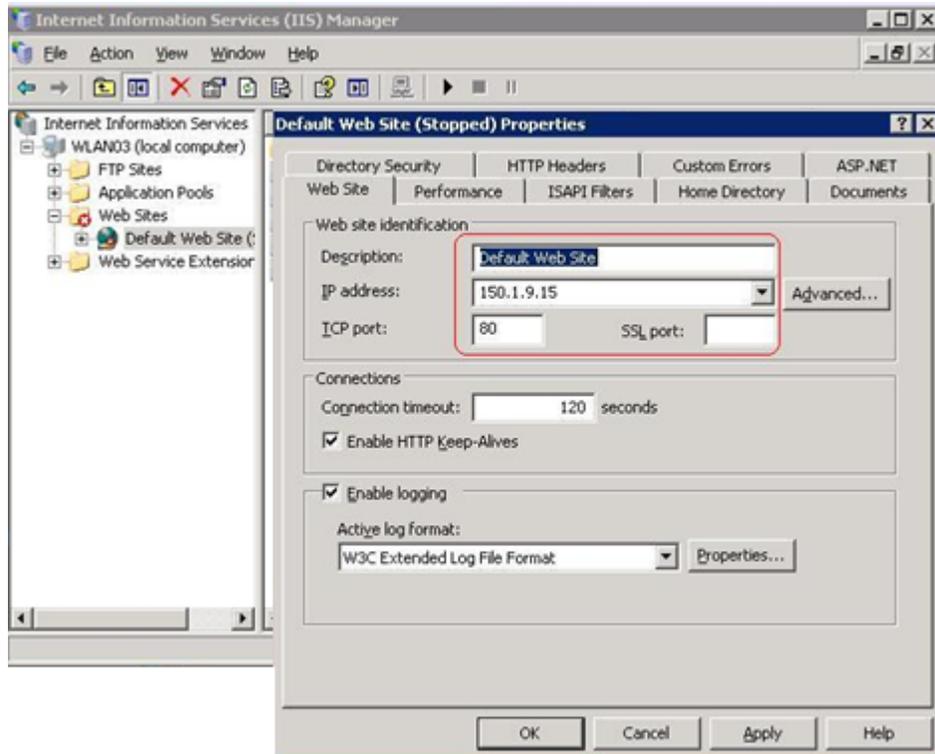
4. Select the **Web Site** tab and provide the IP address and TCP Port as shown in the following graphic.

Figure 2: Windows internet information services Web Site tab

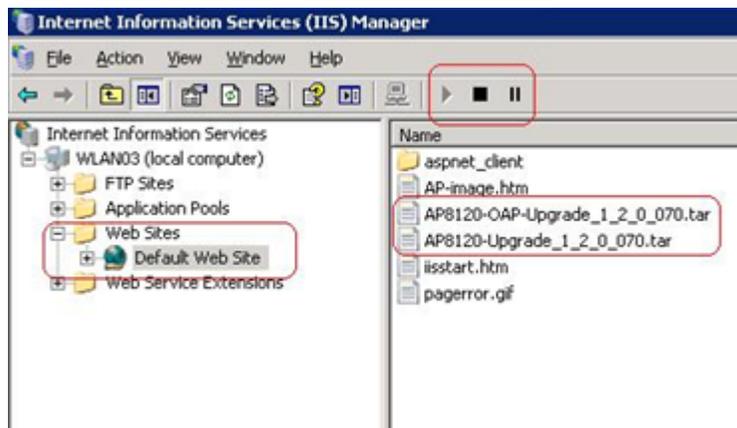
5. Click on the **task** button to run the task service and ensure that the IIS server is reachable from the wireless controller and the access point network.

Figure 3: Windows internet information services task service
