Network OS 7.1.0b for Brocade VDX

Release Notes v2.0

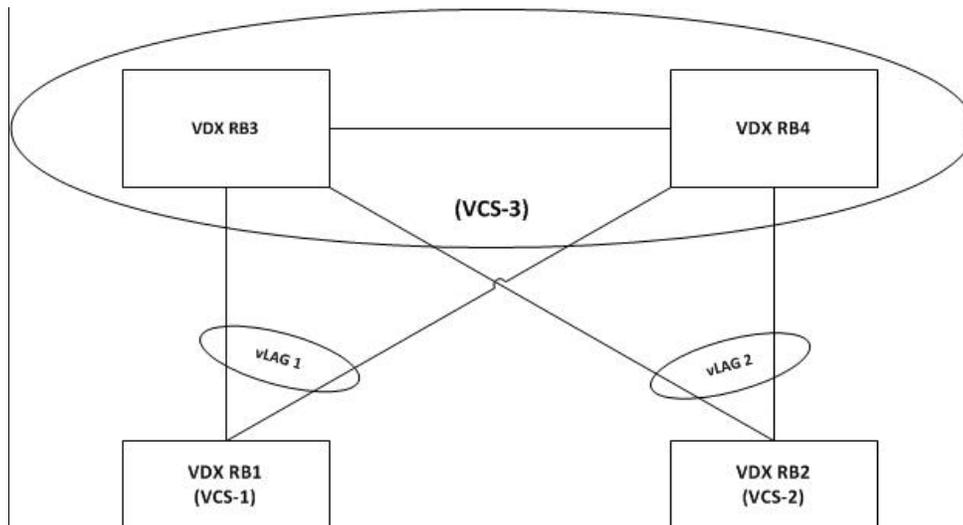
vLAG deployment upgrade illustration

- **Approach 1:** Graceful shutdown of vLAG ports on one node at a time.
- **Approach 2:** Static vLAGs and Dynamic vLAGs without configuration changes.

Approach 1: Graceful shutdown of vLAG ports on one node at a time.

Step 1: If in FC mode, shut the port-channel associated with vLAG 1 on RB3. With LC mode, shutting down port-channel takes down entire port-channel including port-channel interfaces on remote RBs. Therefore, if in LC mode, shut all the member ports of the vLAG 1 on RB3.
