SLX-OS 17s.1.00 for SLX 9140, SLX 9240

Release Notes v2.0

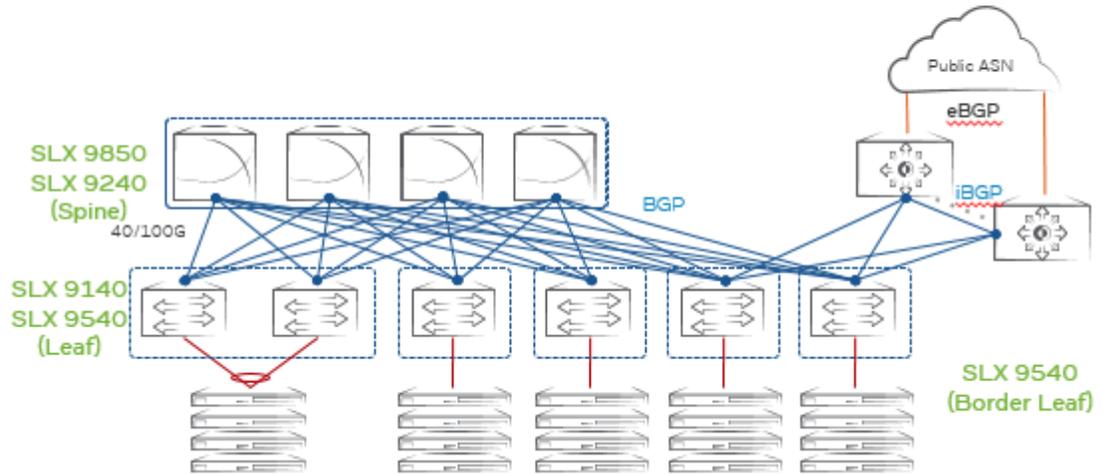
Figure 3: 3-Stage Clos IP fabrics with single or dual-homed servers easily scale

The primary usecase supported in this release is basic IP Fabric.

Use Case	PIN	SLX 9240	SLX 9140	Market Segment
IP Fabric	Spine	Y		CSP, Enterprise DC
	Leaf, Border-Leaf		Y	CSP, Enterprise DC
