SLX-OS 17s.1.01 for SLX 9140, SLX 9240

Release Notes v1.0

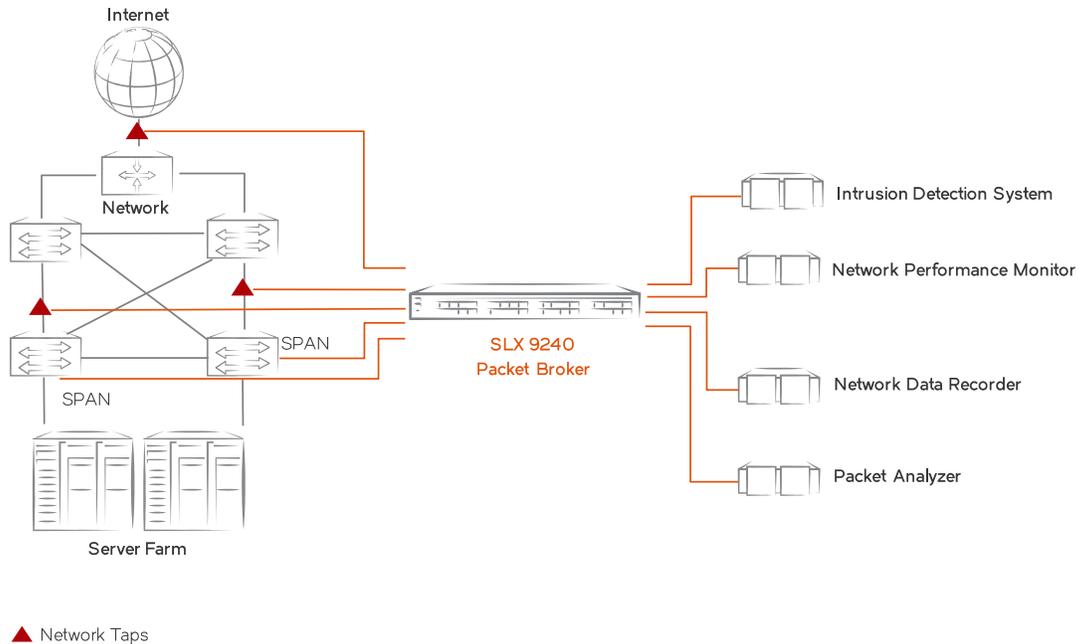
Figure 1: Network Packet Broker

The role of network monitoring and security tools is central to the effective operation and monetization of networks. These tools, in turn, depend on a network visibility infrastructure to deliver a copy of network traffic flows for out-of-band analysis. This version SLX-OS 17s.1.01 of SLX-OS introduces a Network Packet Broker mode, which turns the SLX 9240 into a flexible, high-density member of the Brocade visibility infrastructure portfolio. The following figure illustrates the use case.

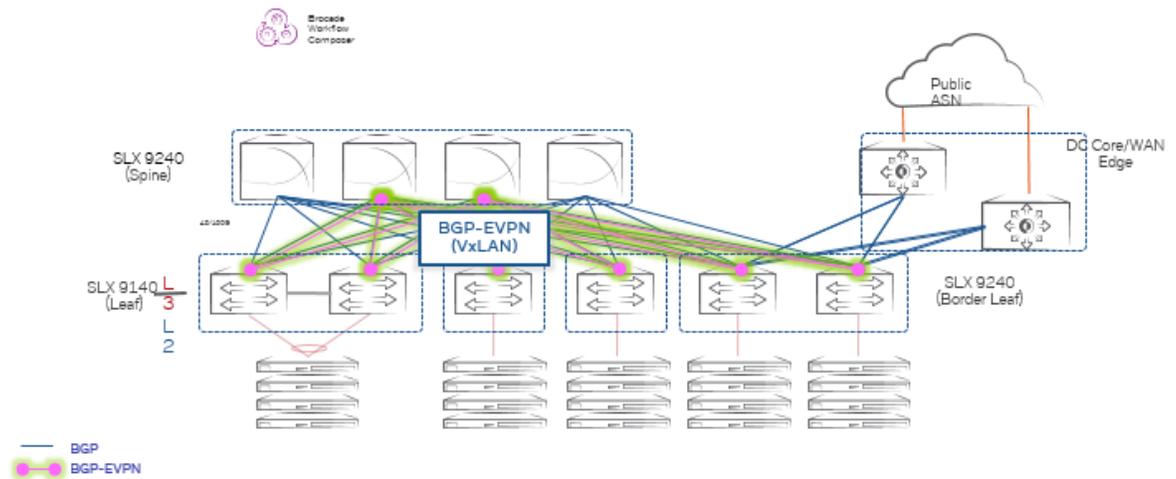
Figure 2: 3-Stage Clos IP fabrics with single or dual-homed servers with BGP-EVPN

Brocade® BGP eVPN Network Virtualization is a controller-less architecture that simplifies data center operations by leveraging open, standards-based protocols to abstract network control plane, data plane, and automation functions from the underlying physical platforms. As an integral part of the Brocade open data center design stack elements (see Figure 3), Brocade BGP eVPN Network Virtualization builds upon underlying infrastructure platforms, fabrics, and automation to deliver simplified and secure network operations.

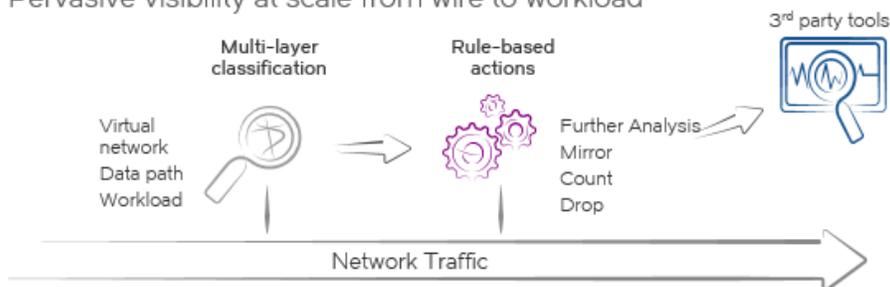
Brocade SLX Visibility Services

Pervasive visibility at scale from wire to workload

- Rich classification and workload matching with network-wide scale
- Automated application of rule-based actions
- Integrates with SLX Insight Architecture, Workflow Composer, and 3rd-party tools

Visibility services provide rich physical, overlay and workload visibility across the network

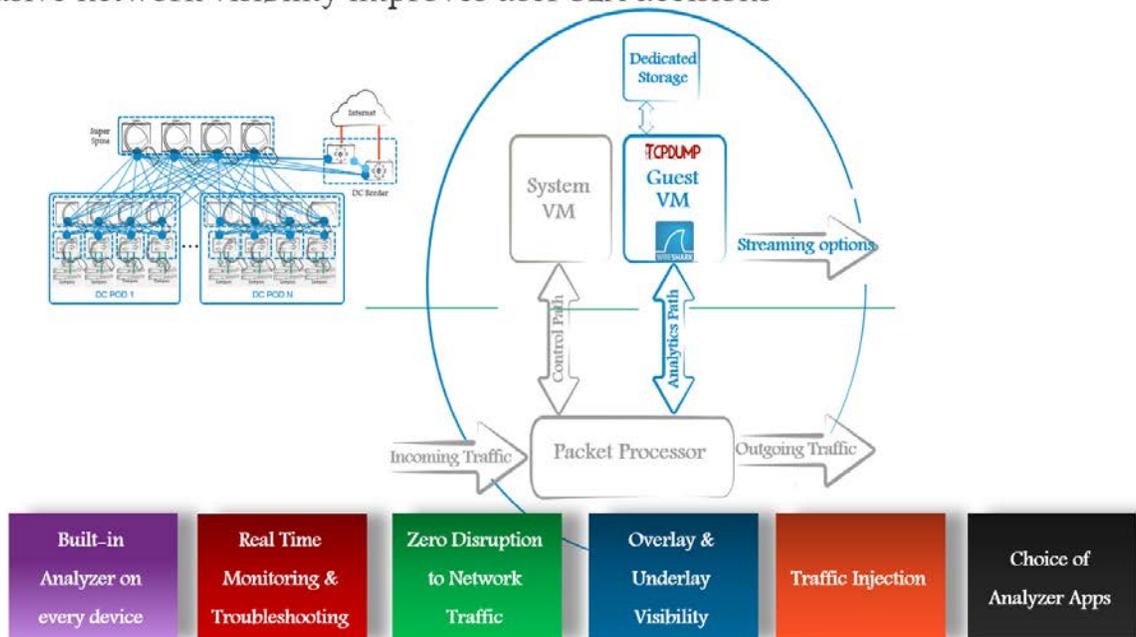
Brocade SLX Insight Architecture

Pervasive network visibility improves user SLA decisions

The Brocade SLX 9140 includes Brocade SLX architecture delivered through this release. This new approach to network monitoring
