# ExtremeXOS Release Notes

*Software Version ExtremeXOS 16.2.5-Patch1-15*

These release notes document ExtremeXOS 16.2.5-Patch1-15 which resolves software deficiencies.

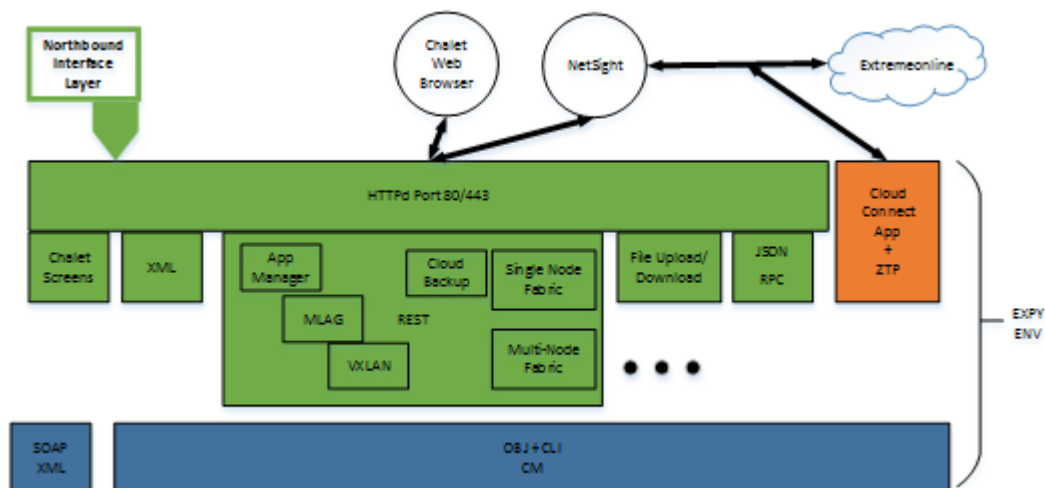
**Figure 1: Application Environment Block Diagram**

ExtremeXOS 16.2 introduces an environment that allows management applications, controllable through a web interface, to communicate directly with other switch management applications.

Applications are management software modules that manage, configure, or monitor specific functions within a switch. The applications leverage existing ExtremeXOS capabilities and protocols to simplify complex tasks. You may download applications to a switch independently from an ExtremeXOS release (see [ezServiceability \(File Upload/Download\)](#) on page 32).

The HTTP interface is now a Python application based on CherryPy (3.7.0). This environment includes the following previously available interfaces:
