Network OS 7.0.1 for VDX

Release Notes v5.0

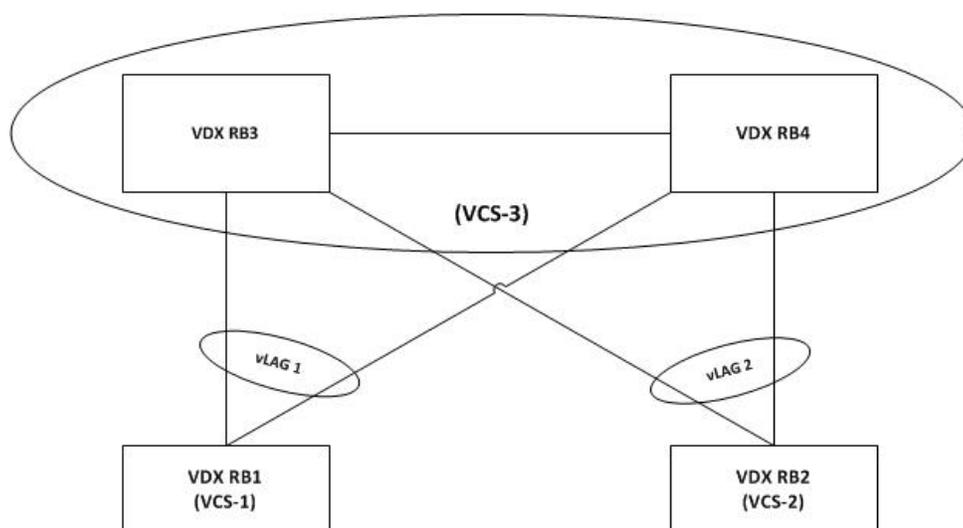
vLAG deployment upgrade Illustration

- **Approach 1:** Graceful shutdown of vLAG ports on one node at a time.
- **Approach 2:** Static vLAGs and Dynamic vLAGs without configuration changes.

Approach 1: Graceful shutdown of vLAG ports on one node at a time.

Step 1: If in FC mode, shut the port-channel associated with vLAG 1 on RB3. With LC mode, shutting down port-channel takes down entire port-channel including port-channel interfaces on remote RBs. Therefore, if in LC mode, shut all the member ports of the vLAG 1 on RB3.
