SLX-OS 18r.2.00a for SLX 9850, SLX 9640, and SLX 9540

Release Notes v1.0

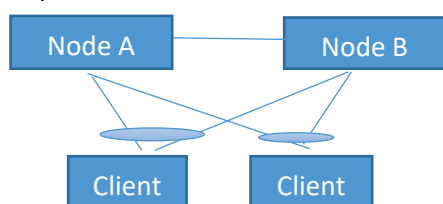
The below steps are written based on the nomenclature used for MCT nodes being A and B

This section describes the procedure to upgrade from SLX-OS 17r.1.01x to SLX-OS 17r.2.01 and later releases with minimal traffic loss disruption to the customer.

1. Configure client-isolation-mode under the cluster to be loose on Node A and Node B respectively.
Device(config)#**cluster** <Name of the cluster> <cluster-id>
client-isolation loose

2. Isolate Node A from the network using the follow steps:
 - a) Disable the MCT clients from the MCT node that needs to be taken offline using **client-interfaces-shutdown** command.
