Ethernet Routing Switch 4800 Series Software Release 5.10.1

1. Release Summary

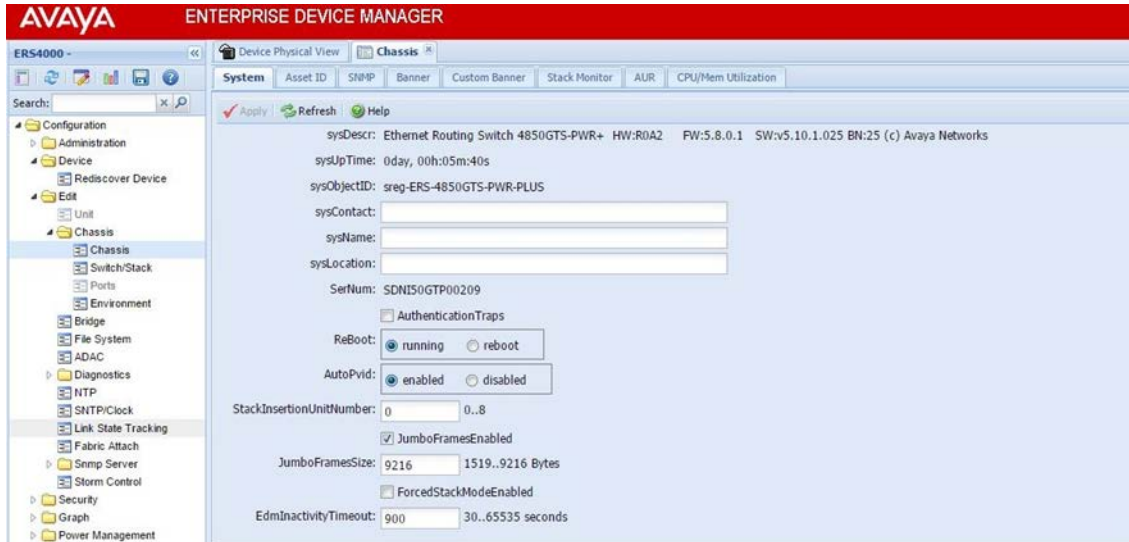
Configuring jumbo frames from EDM:

```
(config)#no jumbo-frames enable
(config)#jumbo-frames enable
(config)#jumbo-frames size ?
    <1519-9216> Jumbo-frames size value
(config)#sh jumbo-frames
Switch Jumbo Frames:
MTU Size: 1518 bytes (1522 bytes for VLAN-tagged frames)
State: Disabled
```
