# **Avaya Release Notes — Release 5.6.3**

## **Avaya Ethernet Routing Switch 4000 Series**

Release 5.6.3  
NN47205-400  
Issue 09.06  
May 2013

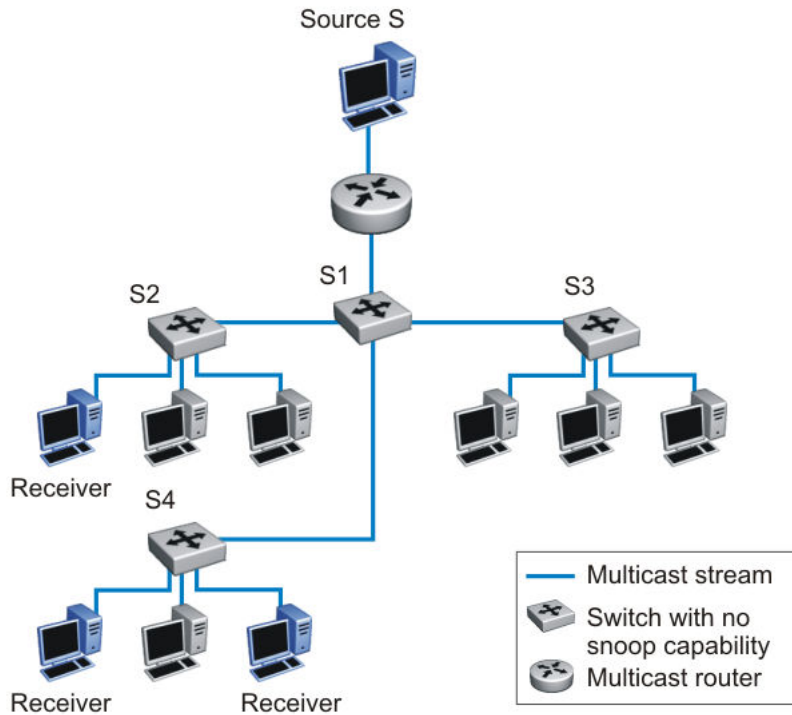
The following figure shows an example of this scenario. Here, the IGMP source provides an IP Multicast stream to a designated router. Because the local network contains receivers, the designated router forwards the IP Multicast stream to the network. Switches without IGMP snoop enabled flood the IP Multicast traffic to all segments on the local subnet. The receivers requesting the traffic receive the desired stream, but so do all other hosts on the network. Although the nonparticipating end stations can filter the IP Multicast traffic, the IP Multicast traffic still exists on the subnet and consumes bandwidth.

**Figure 1: IP multicast propagation on a LAN without IGMP snooping**

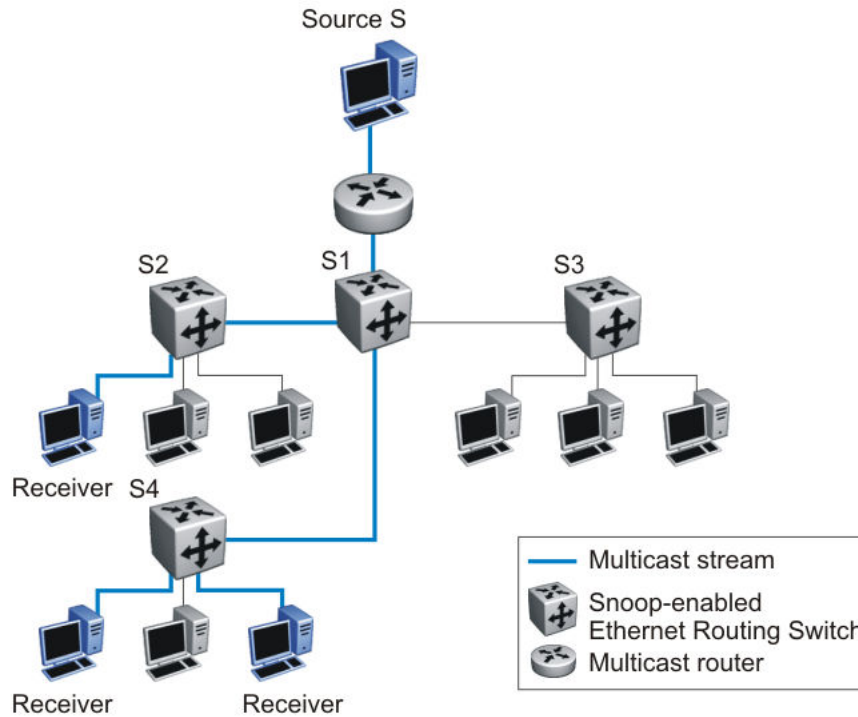
As shown in the following figure, after the switches learn which ports are requesting access to the IP Multicast stream, all other ports not responding to the queries are blocked from receiving the IP Multicast data.

**Figure 2: Ethernet Routing Switch running IGMP snooping**

The Avaya Ethernet Routing Switch 4000 identifies multicast group members by listening to IGMP packets (IGMP reports, leaves, and queries) from each port. The switch suppresses the reports by not forwarding them out to other VLAN ports, forcing the members to continuously send their own reports. The switch uses the information gathered from the reports to build a list of group members. After the group members are identified, the switch blocks the IP Multicast stream from exiting any port that does not connect to a group member, thus conserving bandwidth.
