Avaya Release Notes — Release 5.6 Avaya Ethernet Routing Switch 4000 Series

Release 5.6
NN47205-400
Issue 08.04
May 2013

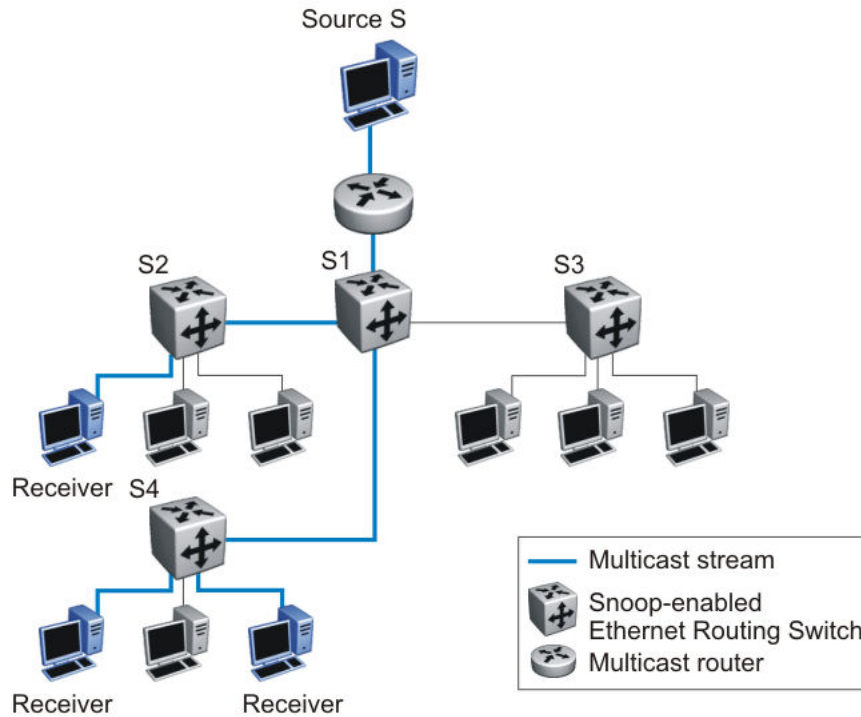
As shown in the following figure, after the switches learn which ports are requesting access to the IP Multicast stream, all other ports not responding to the queries are blocked from receiving the IP Multicast data.

Figure 2: Ethernet Routing Switch running IGMP snooping

To prune ports that are not group members from receiving the group data, the Avaya Ethernet Routing Switch 4000 Series supports IGMP snoop for IGMPv1 and IGMPv2. With IGMP snoop enabled on a VLAN, the switch forwards the multicast group data to only those ports that are members of the group. When using IGMP snoop, VLANs can provide the same benefit as IP Multicast routers, but in the local area.

The Avaya Ethernet Routing Switch 4000 identifies multicast group members by listening to IGMP packets (IGMP reports, leaves, and queries) from each port. The switch suppresses the reports by not forwarding them out to other VLAN ports, forcing the members to continuously send their own reports. The switch uses the information gathered from the reports to build a list of group members. After the group members are identified, the switch blocks the IP Multicast stream from exiting any port that does not connect to a group member, thus conserving bandwidth.
