205679-C Rev 00
December 2000

Passport 4400 Release Notes for R4.1.2

NORTEL
NETWORKS™

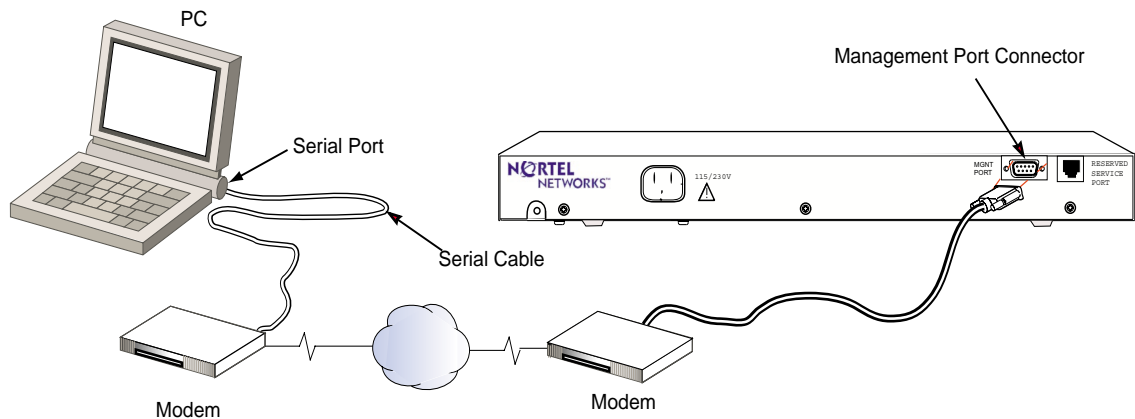
Example

This illustration shows a modem connection on a Passport 4460.

If you are using a modem connection between your workstation and a Passport 4400, the modems at each end of the connection must be configured correctly to support communications with a Passport 4400.
