Part No. 212755-A Rev 00
February 2002

Passport 4400 Release Notes for R4.0.3

NORTEL
NETWORKS™

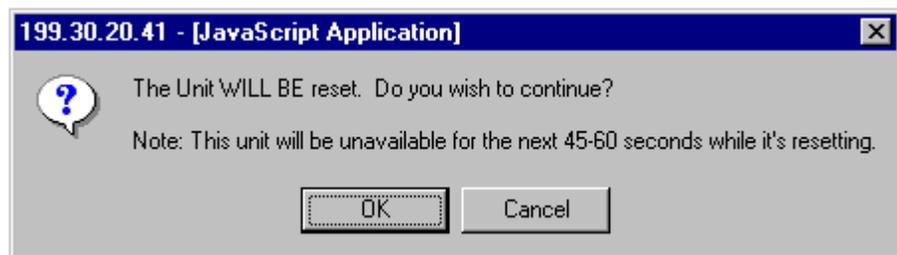
- Click on *Administration*.
- Click on *System Reset*. The System Reset window opens.
- In the Reset Type field, use the pull down menu to select *Configuration*. Click *Reset*. A unit reset confirmation message is displayed.

- Click *OK*. A display will show you the reset progress.

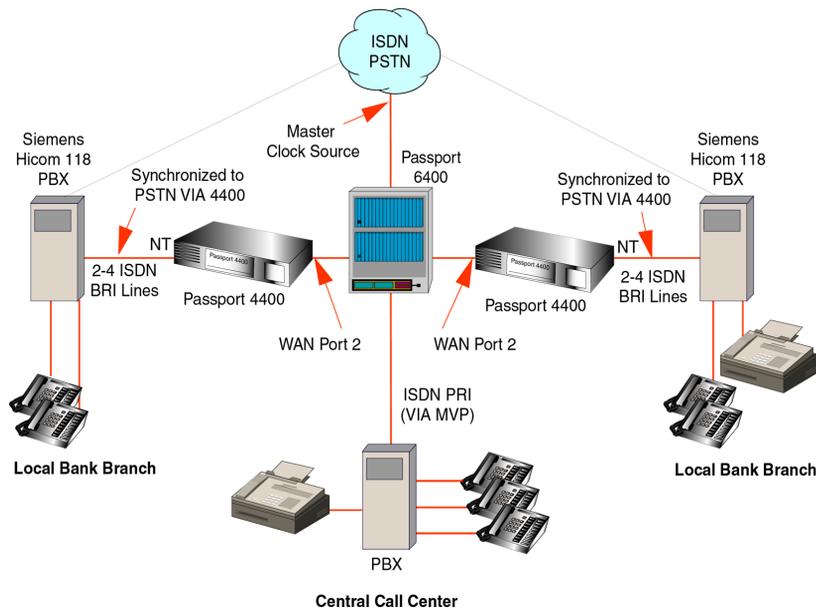
ISDN BRI Voice Module Update/Upgrade (NTAU76CA)

- External synchronization is now provided via a clock sync module (daughter board) installed on this module.
- No configuration required to operate this feature. The module will always look for its clock source from WAN 2 port when configured as NT.
- Required Ethernet Base Module NTAU01CA Rev. 05 or later.

Note: The connections will depend on the specific site requirements. If you are not sure of the connections required for the Passport 4400 unit, consult your system administrator or Certified Distributor or Account Manager.

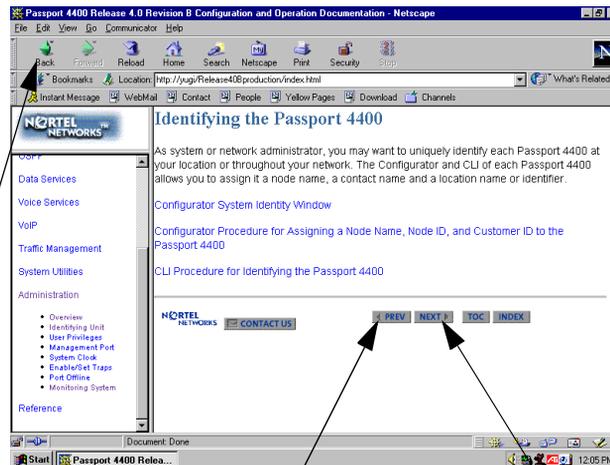
The *next* and *previous* buttons in the document pages navigate you through the pages sequentially. If, for example, you have jumped (hyperlinked) to a new page and wish to return to your previous location, use the *back* button in the browser.

Back. Returns you to the previous display. This is good for jumping between procedures or returning to the previous screen after a hyperlink jump.

PREV. This takes you to the previous page in the document regardless of how you got to this page. Do not confuse this PREV with Back.

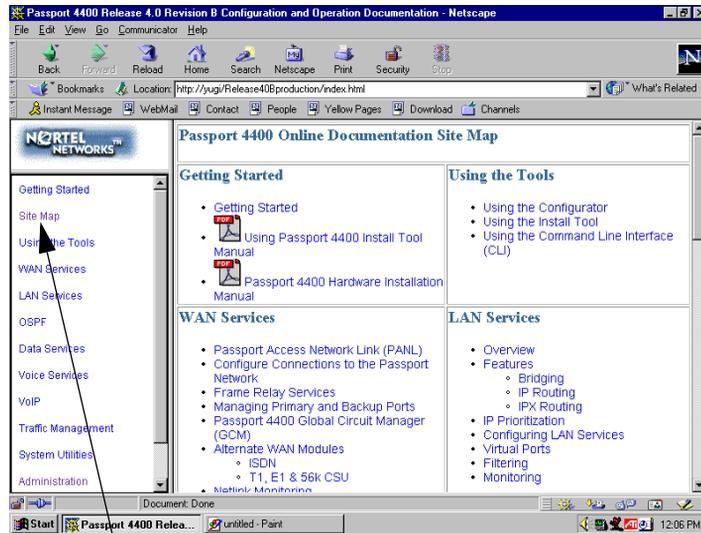
The site map is an expanded version of the Navigation Tree. It permits you to browse through the documents to select the items you wish to view.

From any place in the documentation, select Site Map from the Navigation Tree to display the Site Map

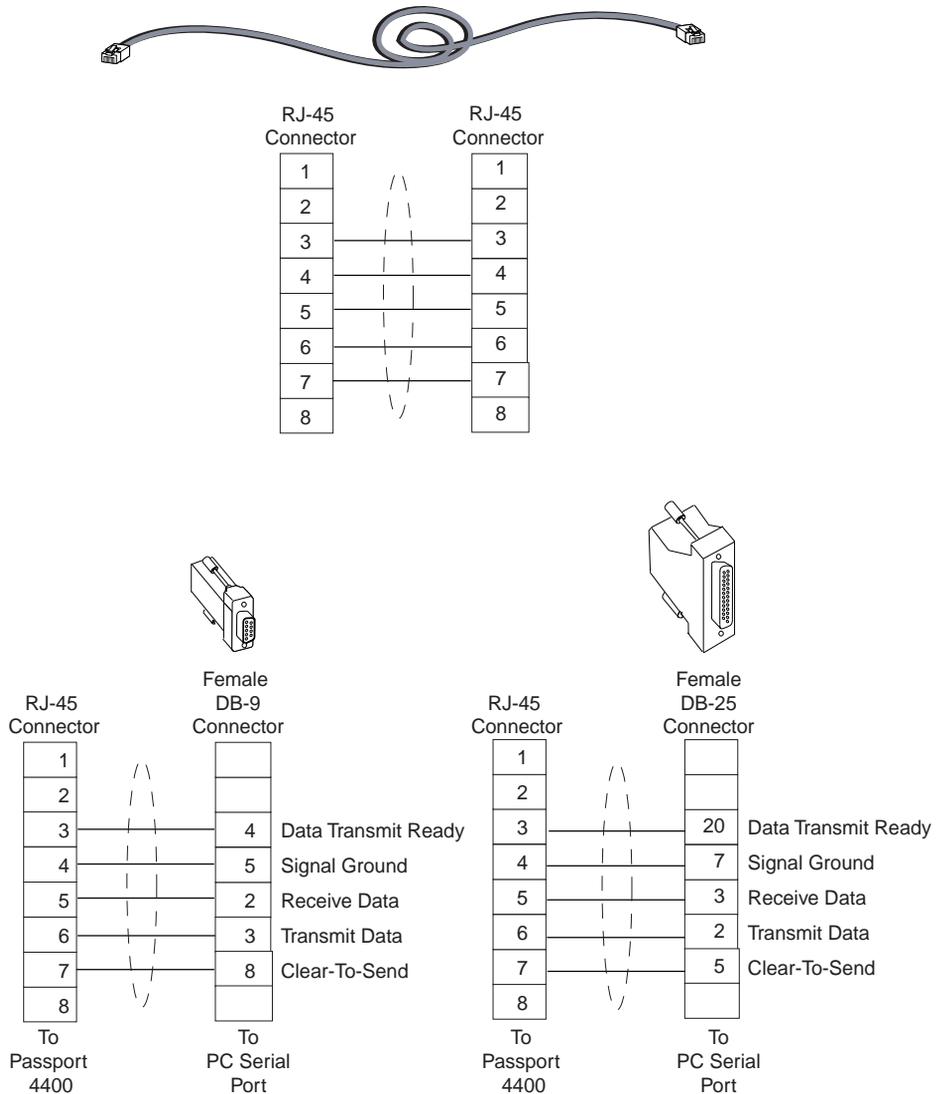
Figure 1 NT0227AA Management Cable

The following cable is available as an optional purchase, as an alternate to the management cable shipped with the hardware. It provides both DB-25 and DB-9 termination.

Note: RJ-45 to either DB-25 or DB-9 DTE
