Part No. 214148-B Rev 00  
July 2003

# Passport 4400 Release Notes for Release 5.1

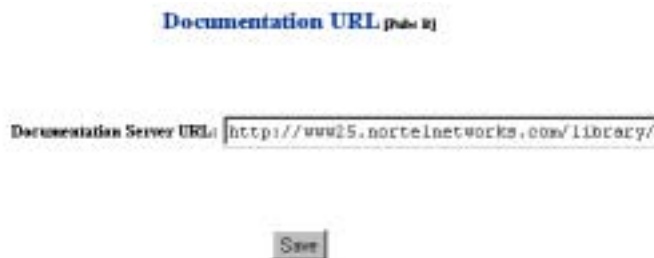
The Documentation URL window opens:

The URL displayed in this window indicates where the online documentation is located (either at the Nortel Networks site (the default), or at a location that you designate).
