Part No. 214148-C Rev 00
March 2004

Passport 4400 Release Notes for Release 5.2

NORTEL
NETWORKS™

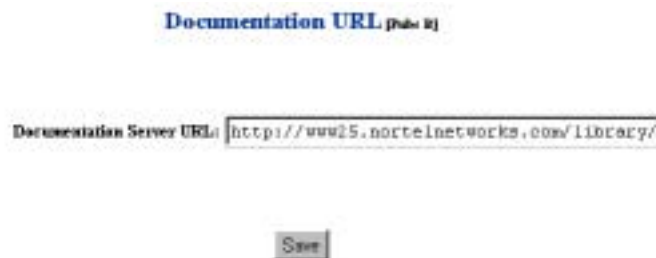
The Documentation URL window opens:

The URL displayed in this window indicates where the online documentation is located (either at the Nortel Networks site (the default), or at a location that you designate).

- 3 If you have downloaded the documentation elsewhere, enter the URL in the Documentation Server URL field, and click *Save*.
