Passport 4400

Release Notes for R3.1.3

Part Number 800-1953-31, Rev. E

November 1999

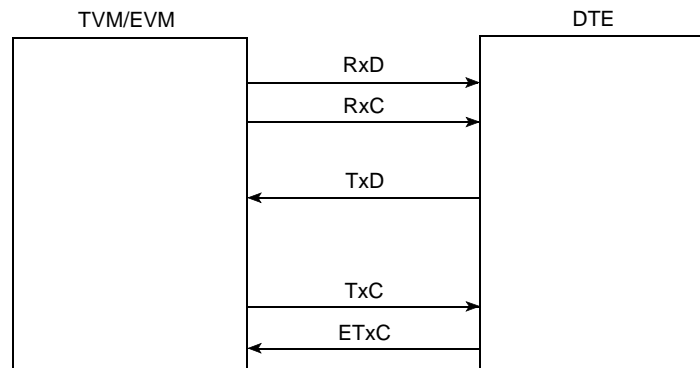
When *internallySupplied* is selected, the attached DTE equipment samples the RxD signal from the TVM/EVM, based on the clock provided by the TVM/EVM. The attached DTE will clock transmit data (TxD) to the Data Port based on the TVM/EVM-provided transmit clock (TxC). The ETxC input to the Data Port is ignored.

Each Data Port is implemented as a DCE interface, and supplies the attached DTE equipment with both TxC and RxC clocks.

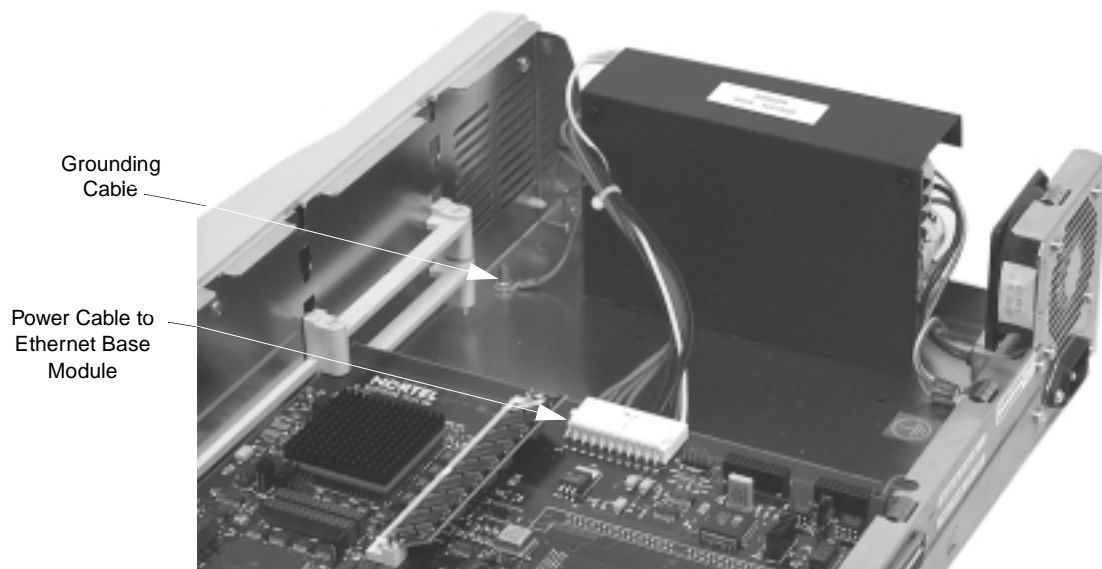
Figure 9-1. 3-slot Power Supply

The 3-slot Passport 4430 chassis uses a 135W AC power supply to provide power to the Ethernet Base Module and expansion modules.

The power cable connects to the Ethernet Base Module. All expansion modules in the unit draw power from the Ethernet Base Module through stacking connectors on the modules.

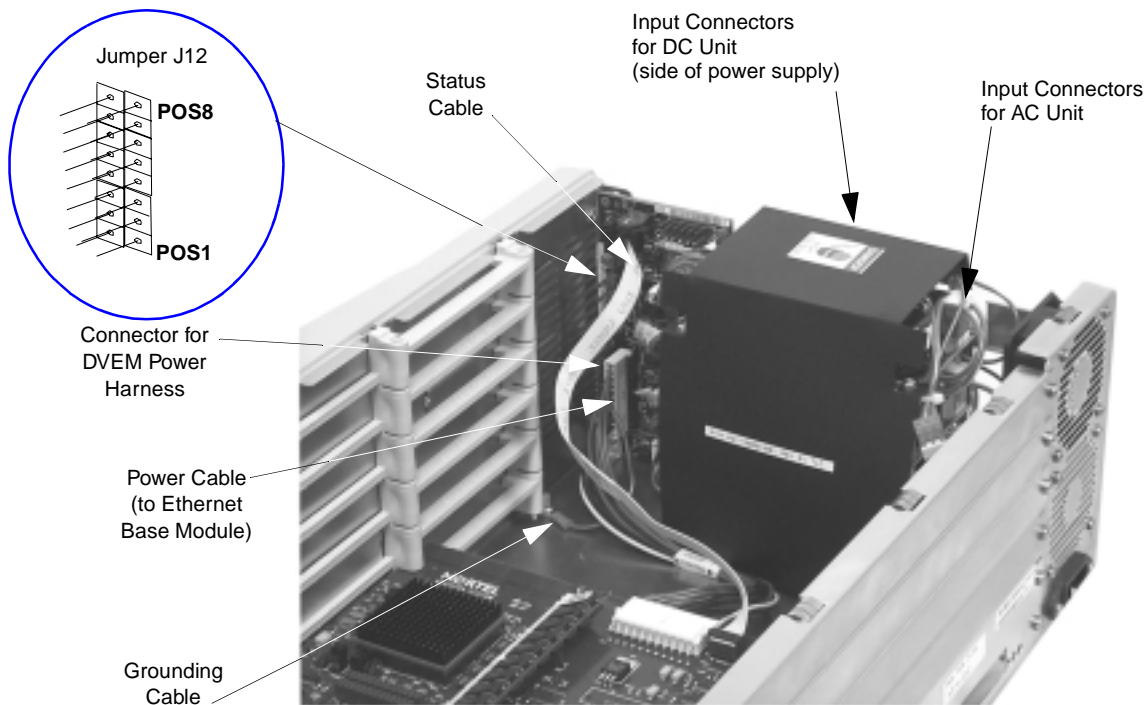
Figure 9-2. 5-slot Passport 4450 Power Supply

The five-slot Passport 4450 chassis uses a 160W power supply to provide power to the Ethernet Base Module and expansion modules. Both AC and DC models are available; the figure below shows an AC unit.

The Digital Voice Expansion Module power harness provides redundant power for Passport 4450 units containing one or more Digital Voice Expansion Modules. The power harness connects the modules to the power sharing board (see Figure 9-2 above, and Figure 5-15 on page 5-14 for more information).

Note: The Input Connectors on the DC power supply are located at the side of the power supply closest to the edge (see Figure 9-2 and Figure 9-3).

The AC input connectors (orange in color) are located at the rear of the unit, behind the fan (see Figure 9-2 on page 9-2).

The DC input connectors (orange in color) are located at the outer side of the power supply (see Figure 9-2 on page 9-2).

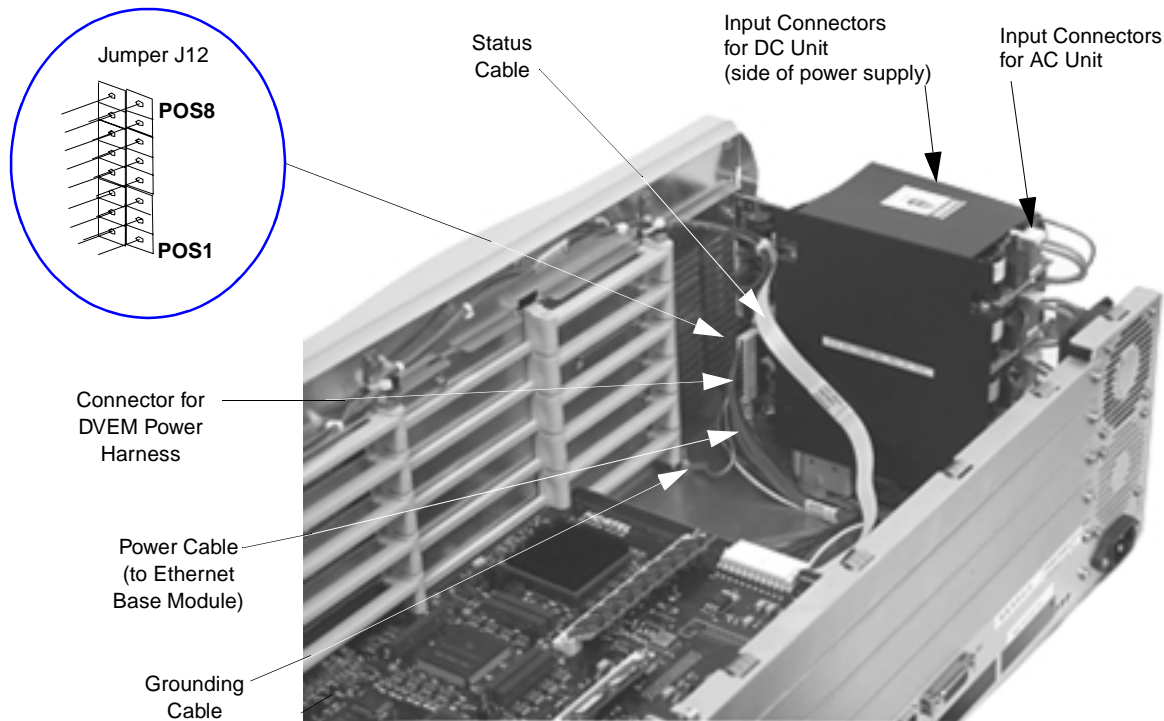
Figure 9-3. 5-slot Passport 4455 with Redundant Power Supply

A 5-slot Passport 4450 chassis with the redundant power supply option contains a subassembly that houses an extra power supply in the event that one of the original four fails. This unit is available in either AC and DC power; the figure below shows an AC unit.

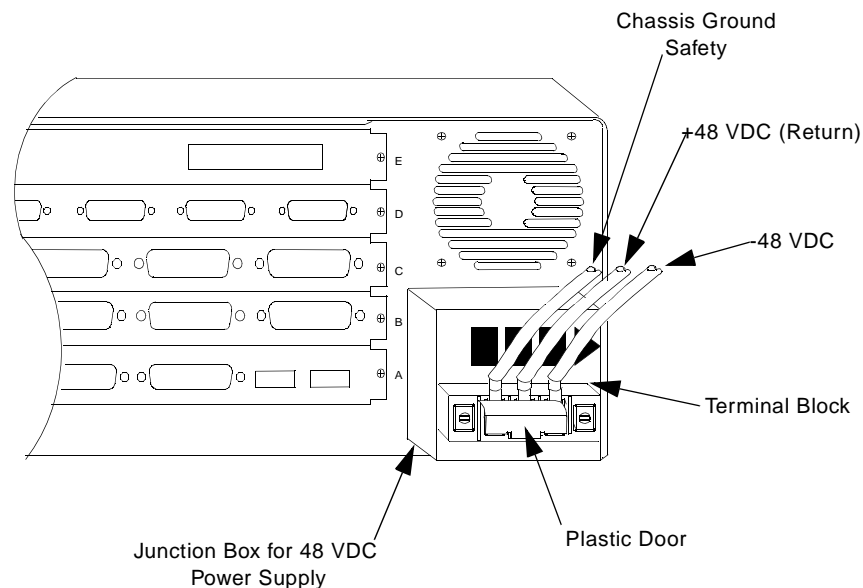
Figure 9-5. DC Power Supply

The -48 volts DC version of the Passport 4400 unit power supply system is identical to the AC version except for the addition of a terminal power adapter that plugs into the line cord Electronic Industry Association (EIA) jack on back of the unit. The five power supplies stack identically to the AC version. The connectors accept the same cables for input and output power.

The DC input voltage must be within the range of -32 volts DC and 72 volts DC. The plus (+) and minus (-) markings on the input power adapter box indicate the polarity of corresponding battery connections. They are electrically floating and can either be connected to house ground or the appropriate DC return. An additional case ground screw is also on the power adapter box. This connection must be grounded to the chassis safety ground for safety and electrical noise suppression. Do not operate the unit without the ground screw connected to the safety ground.
