Passport 4400

Release Notes for R3.1.5

Part Number 800-1953-31, Rev. G

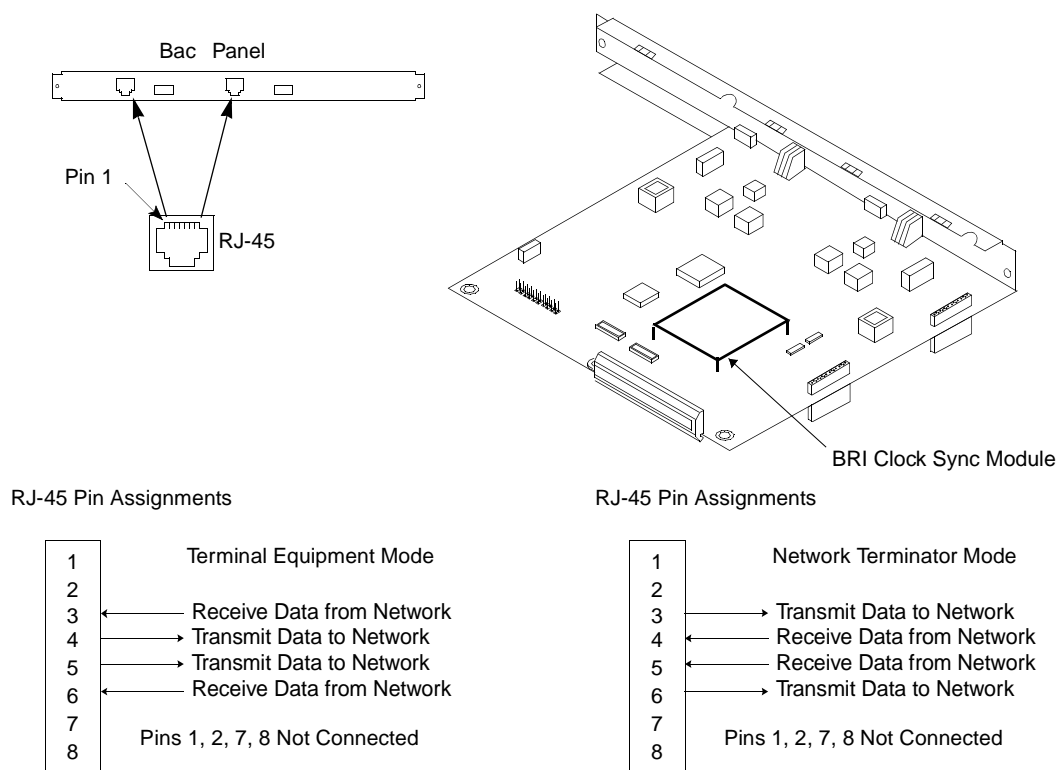
The BRI module connects to the trunk side of an ISDN PBX, serving as one half of an ISDN tie trunk that connects two ISDN PBXs.

Figure 4-1. ISDN BRI Voice Module (S/T) and Pin Assignments

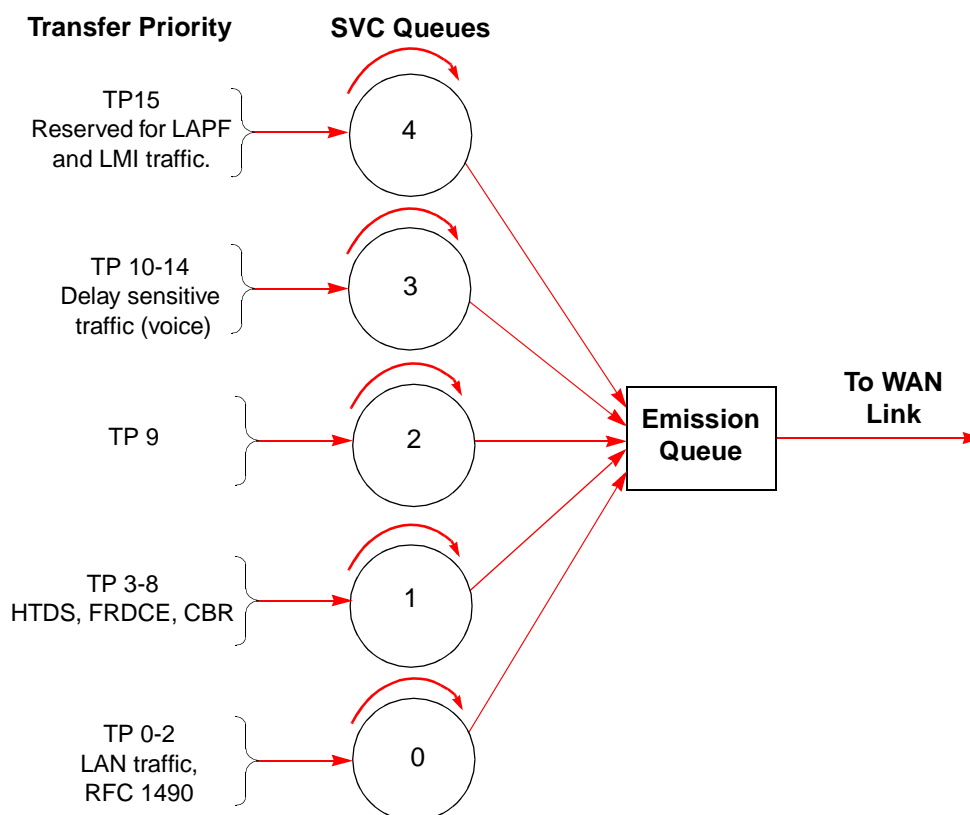
Figure 8-1. Passport 4400 Allocation of Traffic to WAN Link

From the SVC queues, traffic is allocated to fill the outbound (WAN) bandwidth according to its queue number. The WAN link is filled with the higher-priority queues first. For an illustration of how the Passport 4400 fills emission queues and how WAN link bandwidth is allocated, see Figure 8-1.

RFC1490 traffic is not subject to all the same traffic management process that affects other traffic over PANL netlinks. RFC1490 frames will not be fragmented. Notice the position of RFC1490 frames in the outbound traffic flow in Figure 8-1.
