Part No. 210452-C, Rev 00  
January 2001

# Passport 4400 Release Notes for R4.0.2

**NORTEL**  
NETWORKS™

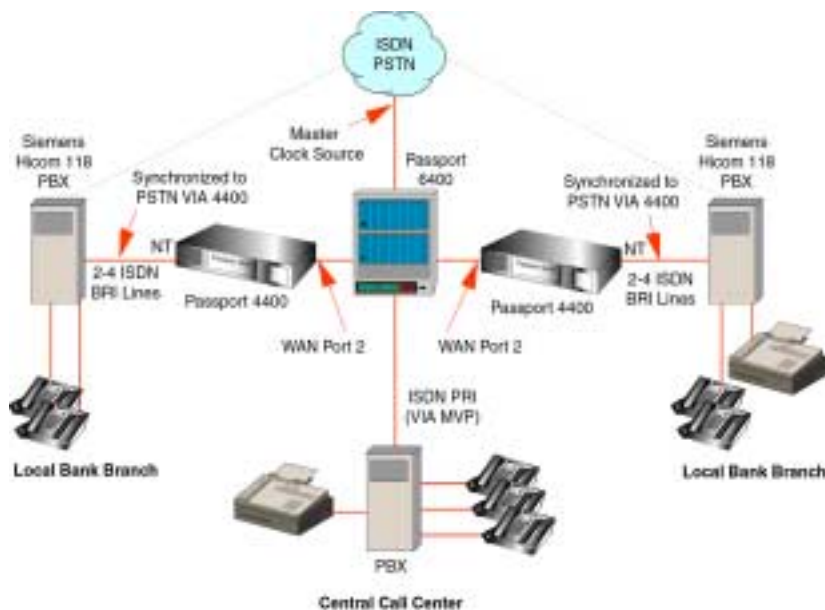
- External synchronization is now provided via a clock sync module (daughter board) installed on this module.
- No configuration required to operate this feature. The module will always look for its clock source from WAN 2 port when configured as NT.
- Required Ethernet Base Module NTAU01CA Rev. 05 or later.

**Note:** The connections will depend on the specific site requirements. If you are not sure of the connections required for the Passport 4400 unit, consult your system administrator or Certified Distributor or Account Manager.

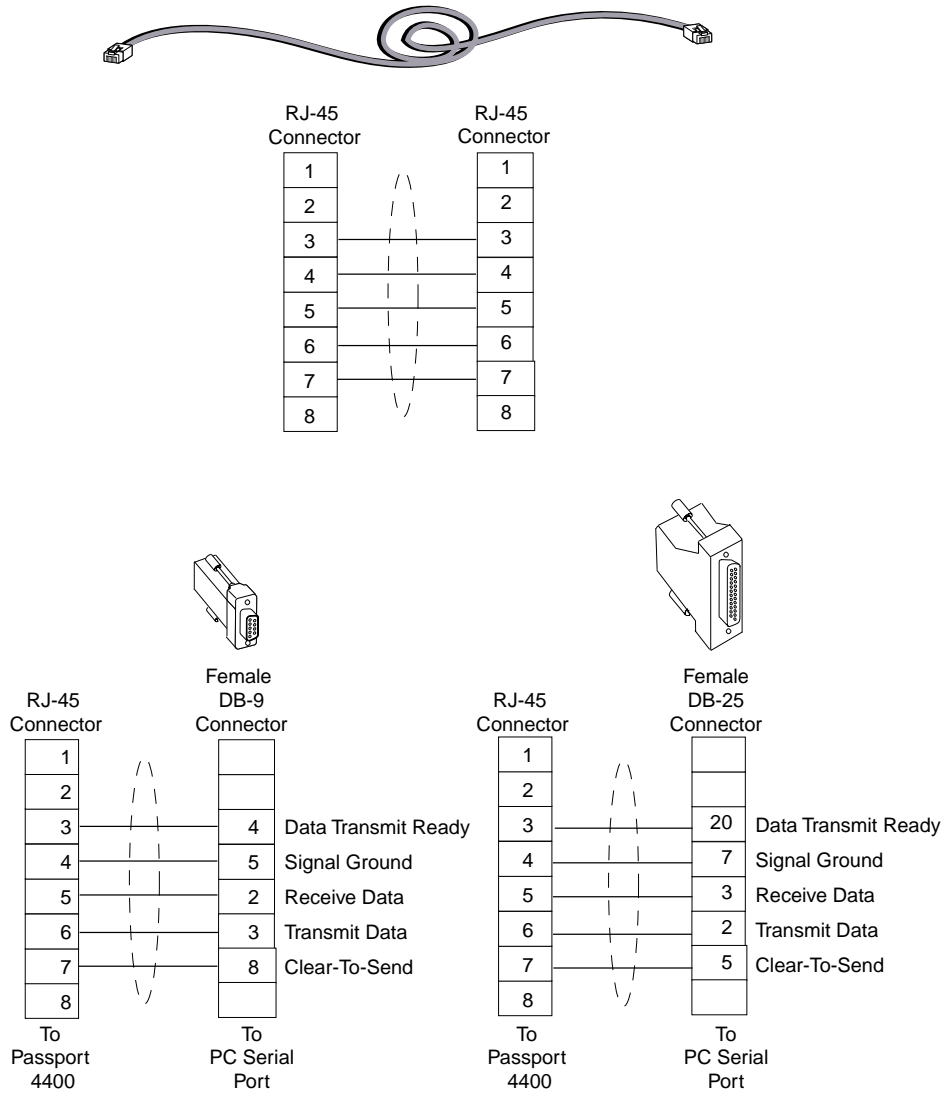
**Figure 1 NT0227AA Management Cable**

- We now offer the following cable as an optional purchase. It is an alternate to the management cable you received with your hardware. It provides both DB-25 and DB-9 termination.

Note: RJ-45 to either DB-25 or DB-9 DTE

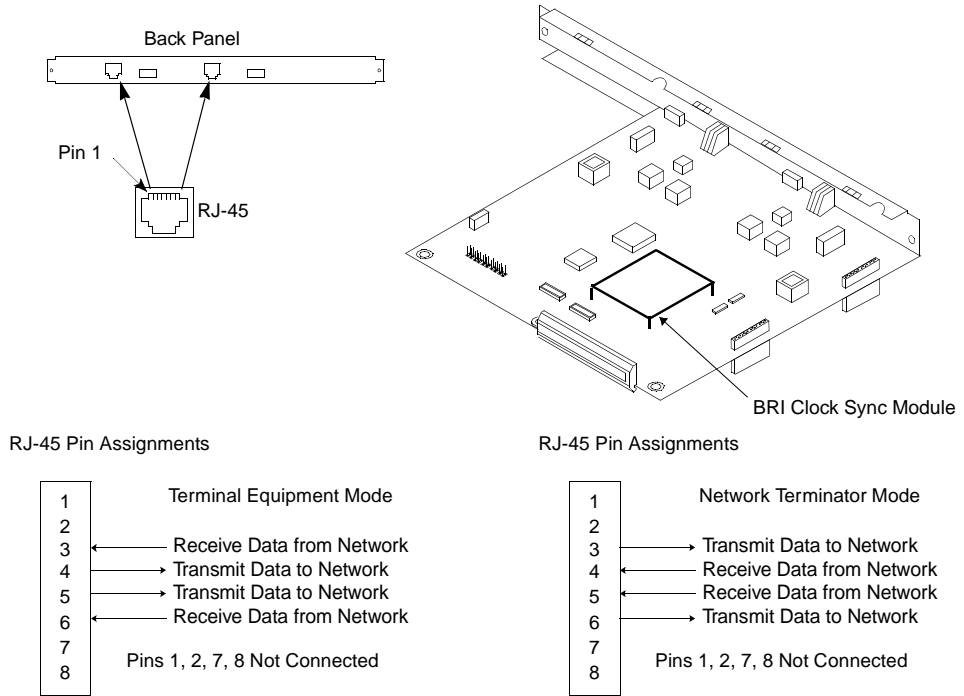
**Figure 2 ISDN BRI Voice Module (S/T) and Pin Assignments**

The BRI module connects to the trunk side of an ISDN PBX, serving as one half of an ISDN tie trunk that connects two ISDN PBXs.

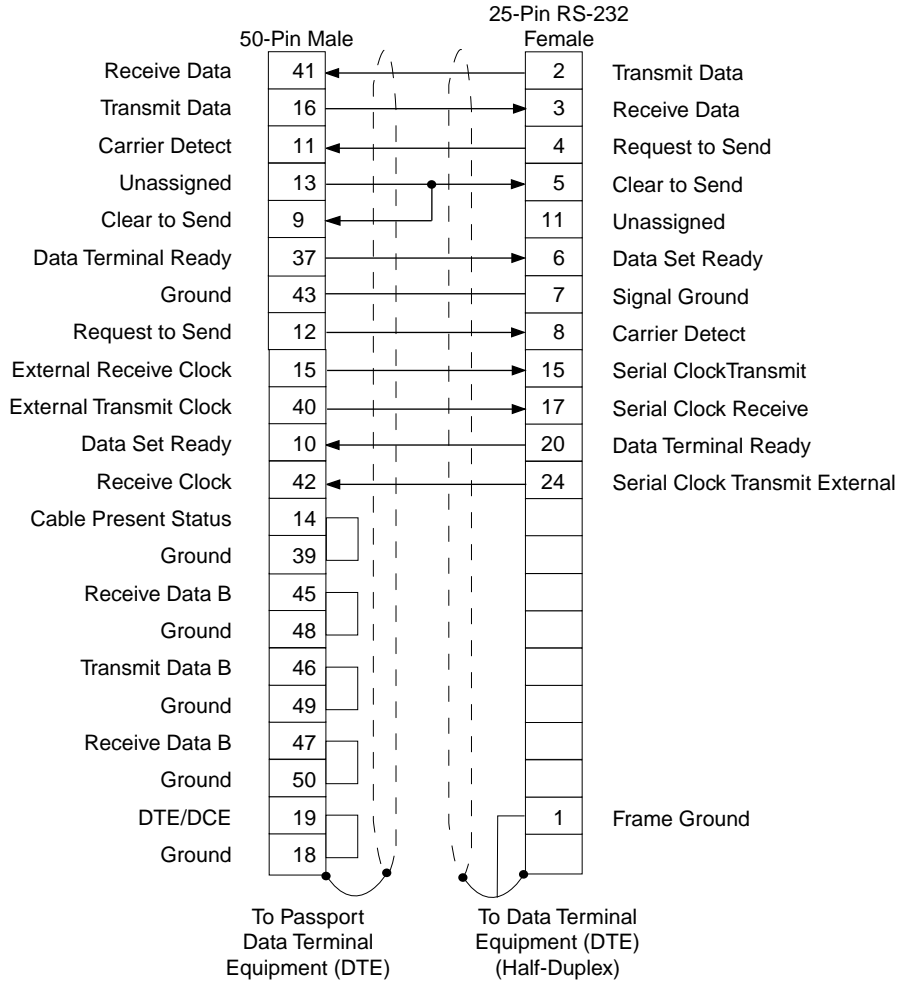
- The following cable, NTO263AA, has been added. This cable sets the CTS high regardless of the idle character setting. This can be used in place of the

NTAU19AA.

## Modem Connection

### Null Modem Pin Assignments
