# Secure Router 1001,1001S, 1002, 1004, and 3120

## Software Release 9.3.3 Readme Notes

### 1. Release Summary

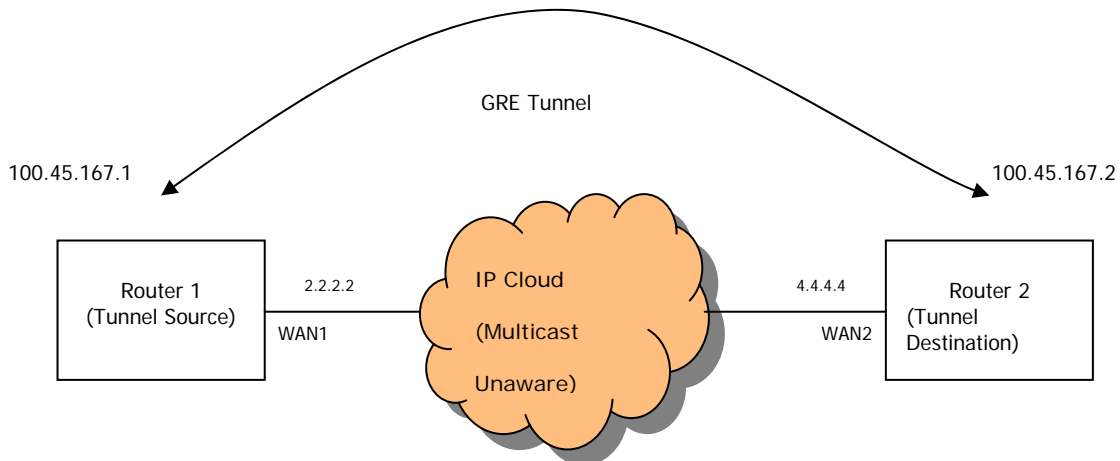
1. When PIM is to be run over GRE tunnels, the GRE tunnels are to be configured with tunnel IP addresses at both the tunnel end-points should be configured in the same subnet. Also, it is mandatory to ensure the reachability to the tunnel destination either via IGP or static route.
2. When configuring PIM over GRE tunnels (Tunnel source configured same as the IP address of the tunnel) configuring the tunnel interface as the CBSR or CRP is not allowed, as the RPF check will fail at the tunnel end point routers (as result of having the 32-bit static route to the tunnel destination).
3. If the BSR/ RP/ Multicast Source networks reside on the other side of the tunnel, the reachability towards the BSR/ RP/ Multicast Source \*should be\* ensured with the next-hop as tunnel's other end, either by IGP or static routes.

The following snapshots illustrate an example configuration:

Nortel Secure Router 1000/3120 version 9.3.2

Below is the sample configuration.
