Avaya WLAN 8100 Release Notes

1.2.1.0
NN47251-400, 05.03
September 2012

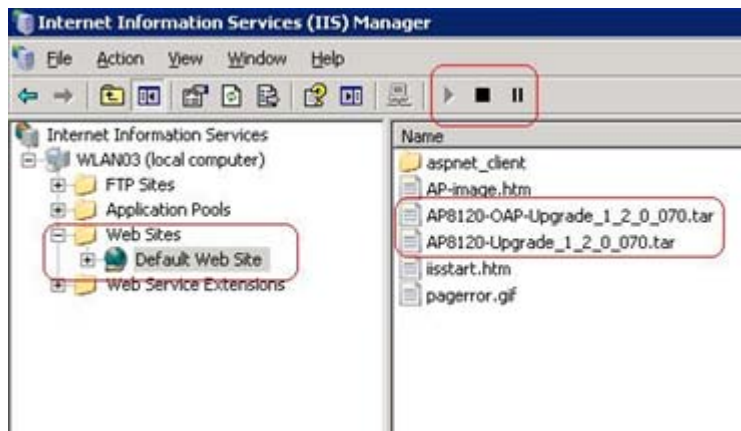
5. Click on the **task** button to run the task service and ensure that the IIS server is reachable from the wireless controller and the access point network.

Figure 3: Windows internet information services task service
