# ISW-168XX PoE Switch Software Release Notes

FW Release Version: v01.01.04.0002 (for all models)

Documentation Date: 2024/01/05

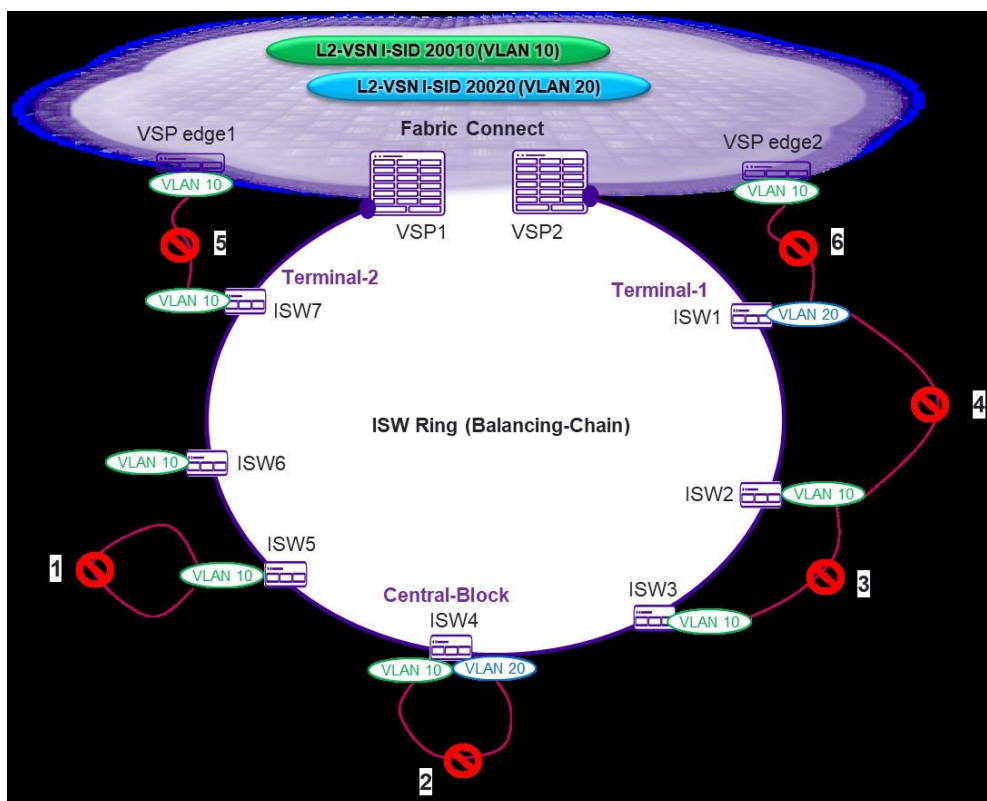
2. Enable loop protect with RingV2

The following cases all can work, the access ports and the ring ports can enable at the same time and work with physical loop.

Description:

Case 1: Loop protect can work when the access ports with loop protect enable in the same VLAN and the same device.

Case 2: Loop protect can work when the access ports with loop protect enable in different VLAN and the same device.

Case 3: Loop protect can work when the access ports with loop protect enable in the same VLAN and the different device.

Case 4: Loop protect can work when the access ports with loop protect enable in the different VLAN and different device.

Case 5: Loop protect can work when the access ports with loop protect enable connected to other vendor's device in the same VLAN.

Case 6: Loop protect can work when the access ports with loop protect enable connected to other vendor's device in the different VLAN.

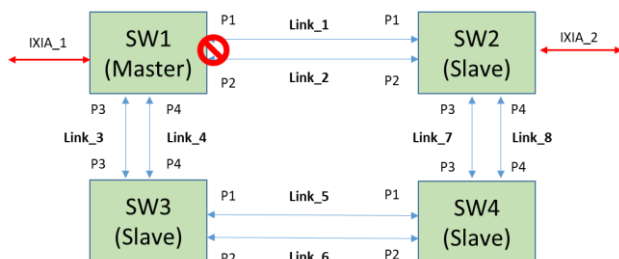
■ Ring with LAG

- Supported topologies:  
Average recovery time are same as original Ring technologies (Almost same as without LAG). The recovery time is less than 50ms.

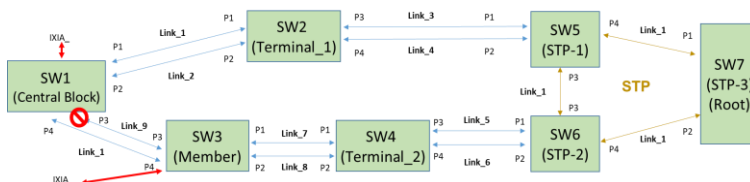
■ Balancing Chain with LAG + STP

- Supported topologies but not support to use due to bad recovery time.

Bad recovery time on Link\_3, Link\_4, Link\_5 and Link\_6.

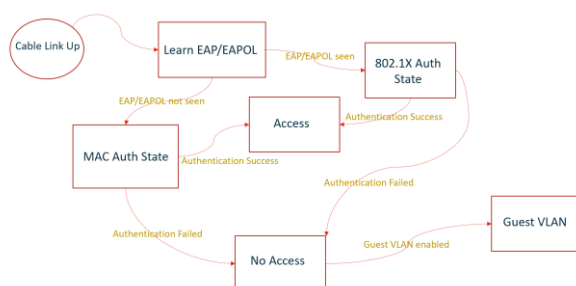
### State chart of 802.1X/MAC auto sense mode

- Mode States
  - Try to authenticate through 802.1X else
  - Try to authenticate through MAC else
  - Provide Guest VLAN access (if Guest VLAN is enabled) else
  - No Access

- New timer parameter: Sense Period  
Used to identify if the client enabled 802.1X. Identification method is to learning if the port received EAP/EAPOL packets, the first learnt packet will be EAPOL start normally after port is linked up.
  - CLI:  
(config)#dot1x timeout sense-period <10-255>, default: 10 seconds
- New mode of port control: dot1x port-control sense  
To support enable both MAC and 802.1X auth on same port.
  - CLI:  
(config-if)# dot1x port-control sense

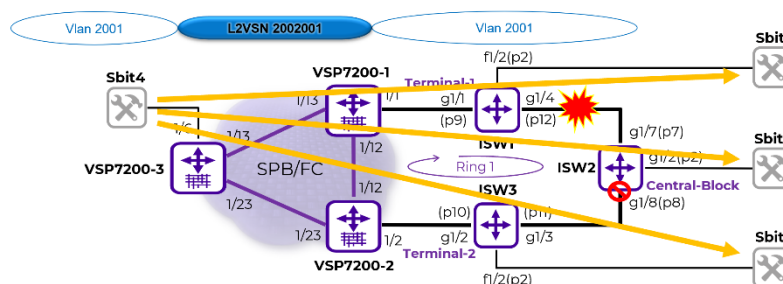
- TCN (topology change notification) of MSTP.  
ISW Ringv2(Chain/Balancing Chain) support MSTP/RSTP TCN BPDU for fast (less than 100ms) network redundancy recovery time.

- Ring Cut (64 millisecs interruption)

Signature Frames Sent	0	0	0	0	0	0	238,194	0	Sbit1	Sbit2	Sbit3
Signature Frames Received	79,398	0	79,334	0	79,398	0	0	0	0	64	0
