# Network OS 6.0.2h for Extreme VDX

## Release Notes v3.0

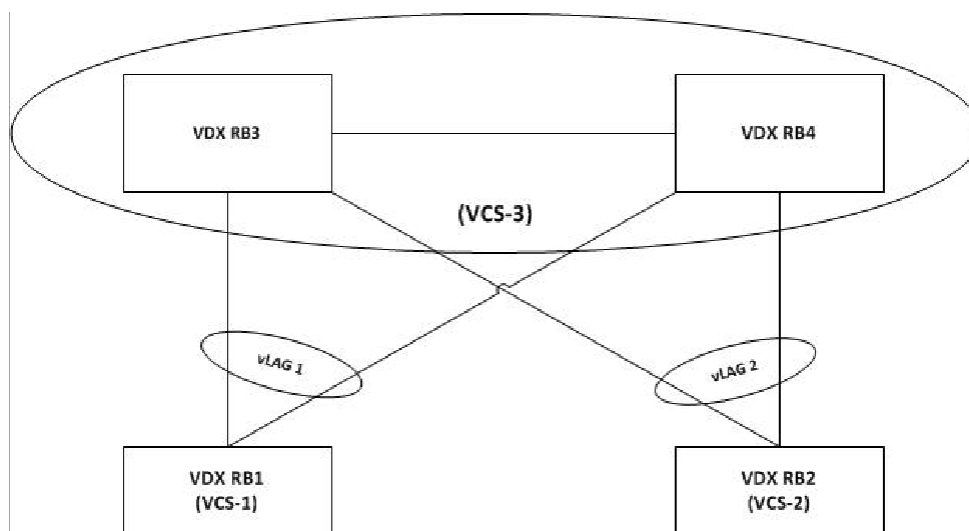
### vLAG deployment upgrade illustration

**Approach 1:** Graceful shutdown of vLAG ports on one node at a time.

**Step 1:** If in FC mode, shut the port-channel associated with vLAG 1 on RB3. With LC mode, shutting down port-channel takes down entire port-channel including port-channel interfaces on remote RBs. Therefore, if in LC mode, shut all the member ports of the vLAG 1 on RB3.

- **Approach 1:** Graceful shutdown of vLAG ports on one node at a time.
- **Approach 2:** Static vLAGs and Dynamic vLAGs without configuration changes.
