January 2021

Extreme Network OS 7.2.0f for Extreme VDX devices Release Notes

9036239-03 Rev AA

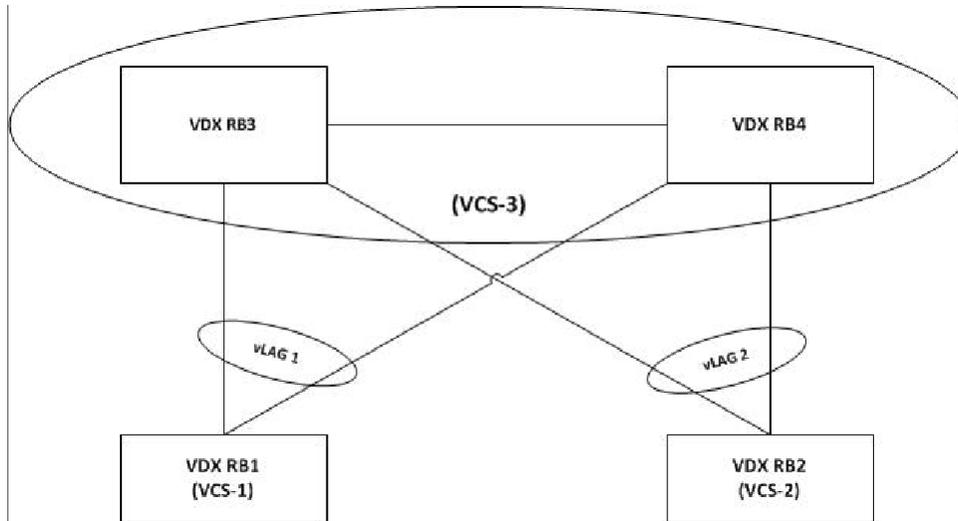
vLAG deployment upgrade Illustration

- **Approach 1:** Graceful shutdown of vLAG ports on one node at a time.
- **Approach 2:** Static vLAGs and Dynamic vLAGs without configuration changes.

Approach 1: Graceful shutdown of vLAG ports on one node at a time.

Step 1: With LC mode, shutting down port-channel takes down entire port-channel including port-channel interfaces on remote RBs. Therefore, if in LC mode, shut all the member ports of the vLAG 1 on RB3.

Ignore-split on (default): No impact/reconvergence to Static or Dynamic vLAGs. Minimal data path impact observed.
