Network OS 7.2.0a for VDX

Release Notes v2.0

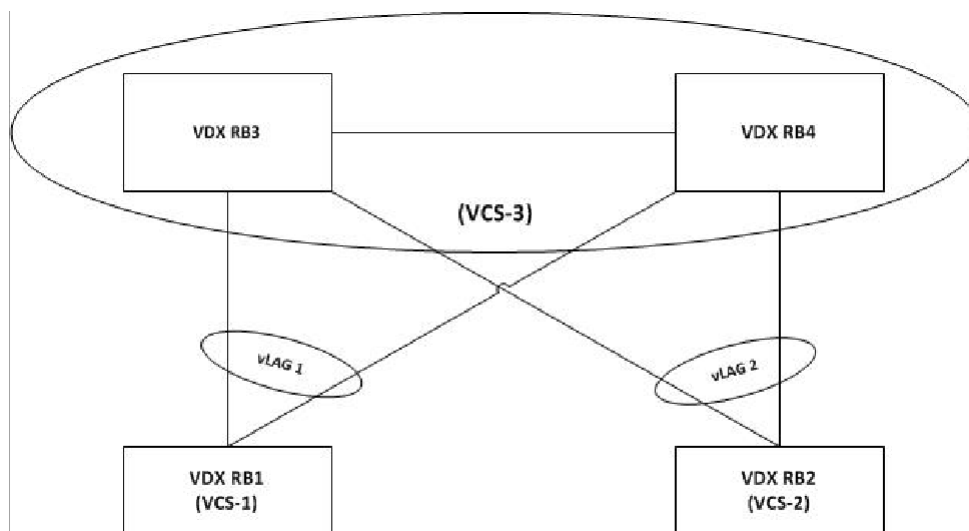
vLAG deployment upgrade Illustration

- **Approach 1:** Graceful shutdown of vLAG ports on one node at a time.
- **Approach 2:** Static vLAGs and Dynamic vLAGs without configuration changes.

Approach 1: Graceful shutdown of vLAG ports on one node at a time.

Step 1: With LC mode, shutting down port-channel takes down entire port-channel including port-channel interfaces on remote RBs. Therefore, if in LC mode, shut all the member ports of the vLAG 1 on RB3.
