Network OS 7.3.0 for VDX

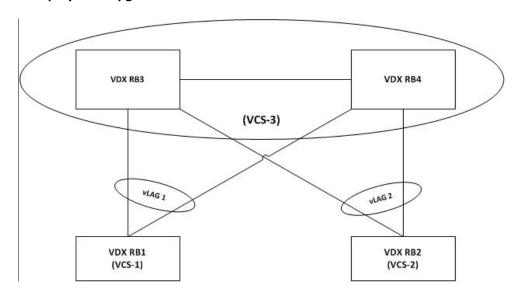
vLAG deployment upgrade Illustration

- **Approach 1**: Graceful shutdown of vLAG ports on one node at a time.
- Approach 2: Static vLAGs and Dynamic vLAGs without configuration changes.

Approach 1: Graceful shutdown of vLAG ports on one node at a time.

Step 1: With LC mode, shutting down port-channel takes down entire port-channel including port-channel interfaces on remote RBs. Therefore, if in LC mode, shut all the member ports of the vLAG 1 on RB3.
