Network OS 7.3.0a for VDX

Release Notes v2.0

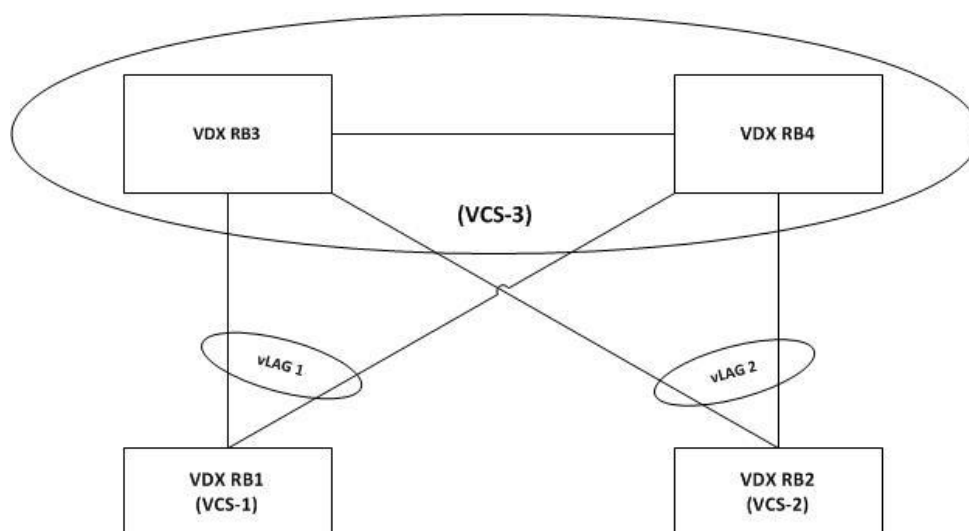
vLAG deployment upgrade Illustration

- **Approach 1:** Graceful shutdown of vLAG ports on one node at a time.
- **Approach 2:** Static vLAGs and Dynamic vLAGs without configuration changes.

Approach 1: Graceful shutdown of vLAG ports on one node at a time.

Step 1: With LC mode, shutting down port-channel takes down entire port-channel including port-channel interfaces on remote RBs. Therefore, if in LC mode, shut all the member ports of the vLAG 1 on RB3.
