# Network OS 7.4.1f for Extreme VDX

## Release Notes

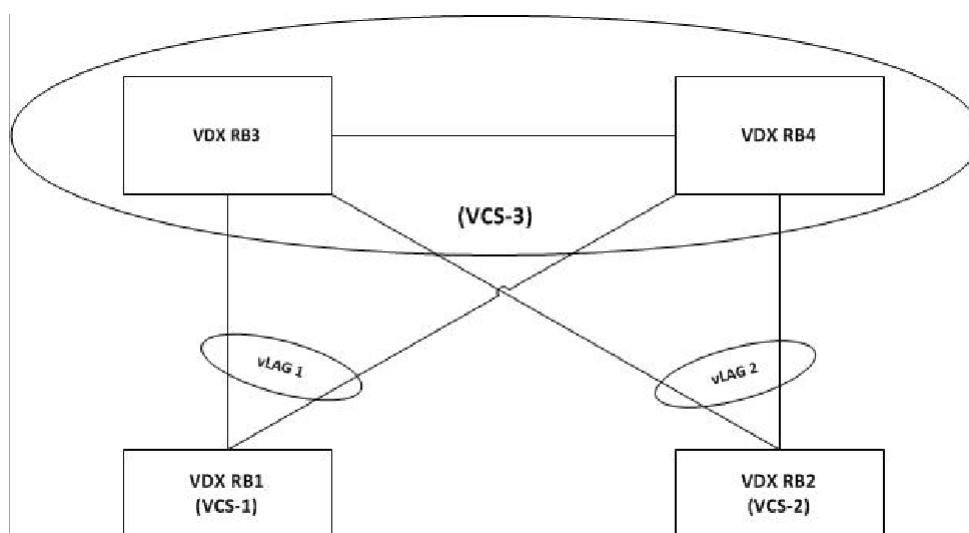
### vLAG deployment upgrade Illustration

- **Approach 1:** Graceful shutdown of vLAG ports on one node at a time.
- **Approach 2:** Static vLAGs and Dynamic vLAGs without configuration changes.

#### **Approach 1:** Graceful shutdown of vLAG ports on one node at a time.

**Step 1:** With LC mode, shutting down port-channel takes down entire port-channel including port-channel interfaces on remote RBs. Therefore, if in LC mode, shut all the member ports of the vLAG 1 on RB3.
