Network OS 7.4.1k for Extreme VDX

Release Notes

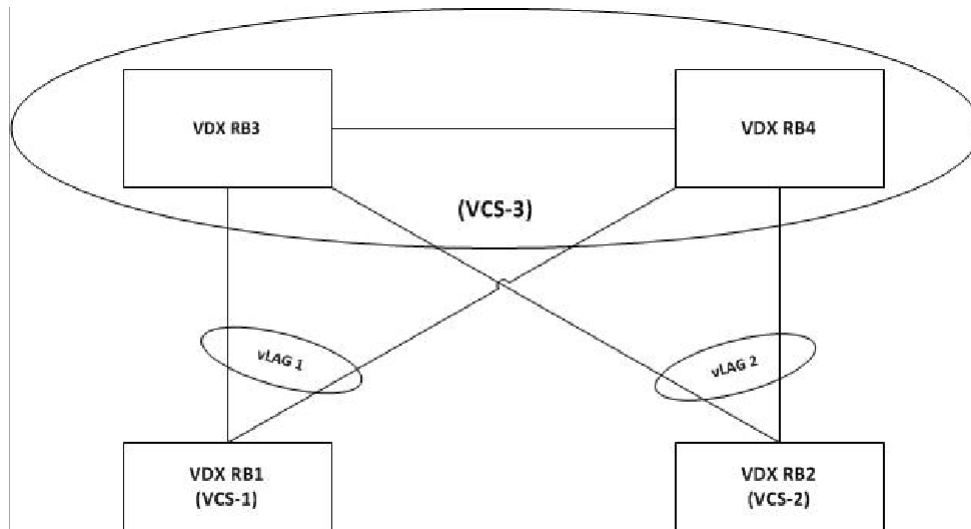
vLAG deployment upgrade illustration

- **Approach 1:** Graceful shutdown of vLAG ports on one node at a time.
- **Approach 2:** Static vLAGs and Dynamic vLAGs without configuration changes.

Approach 1: Graceful shutdown of vLAG ports on one node at a time.

Step 1: With LC mode, shutting down port-channel takes down entire port-channel including port-channel interfaces on remote RBs. Therefore, if in LC mode, shut all the member ports of the vLAG 1 on RB3.
