Network OS 7.4.1 for Extreme VDX

Release Notes

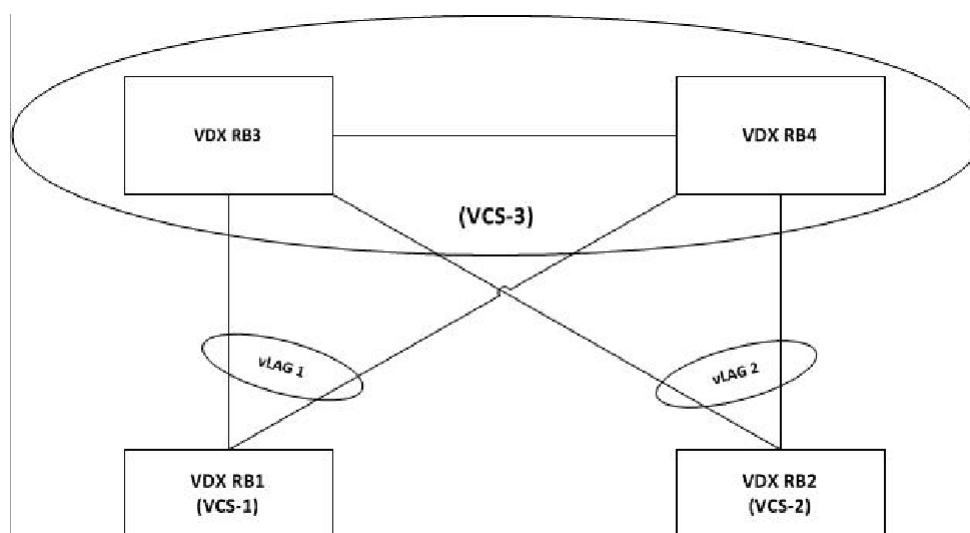
vLAG deployment upgrade Illustration

- **Approach 1:** Graceful shutdown of vLAG ports on one node at a time.
- **Approach 2:** Static vLAGs and Dynamic vLAGs without configuration changes.

Approach 1: Graceful shutdown of vLAG ports on one node at a time.

Step 1: With LC mode, shutting down port-channel takes down entire port-channel including port-channel interfaces on remote RBs. Therefore, if in LC mode, shut all the member ports of the vLAG 1 on RB3.
