# Extreme SLX-OS 17r.2.01a for ExtremeRouting SLX 9850 and ExtremeSwitching SLX 9540

## Release Notes v3.0

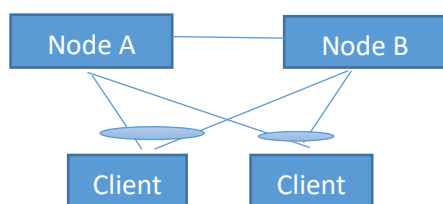
This section describes the procedure to upgrade from SLX-OS 17r.1.01x to SLX-OS 17r.2.01 and later releases with minimal traffic loss disruption to the customer.

The below steps are written based on the nomenclature used for MCT nodes being A and B

1. Configure client-isolation-mode under the cluster to be loose on Node A and Node B respectively.
