SLX-OS 18r.1.00n for SLX 9850 and SLX 9540

Release Notes

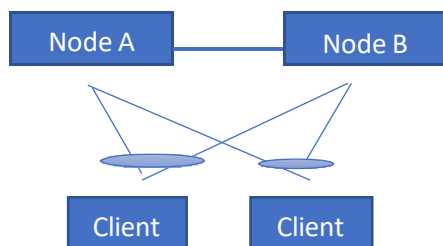
The steps in the MCT upgrade process use the following nomenclature for MCT nodes: Node A and Node B.

1. MCT upgrade process from SLX-OS 17r.1.01x to SLX-OS 18r.1.00d (32-bit OS to 64-bit OS)
2. MCT upgrade process from SLX-OS 18r.1.00 to SLX-OS 18r.1.00d (64-bit OS to 64-bit OS)
