SLX-OS 18r.1.00p for SLX 9850 and SLX 9540

Release Notes

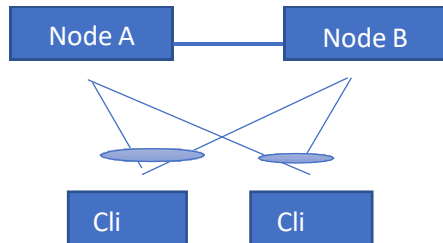
The steps in the MCT upgrade process use the following nomenclature for MCT nodes: Node A and Node B.

MCT upgrade process from SLX-OS 17r.1.01x to SLX-OS 18r.1.00d:

1. Configure client isolation mode under the cluster to be loose on Node A and on Node B respectively using the client-isolation loose command. For example:
